# Martha's Vineyard Hybrid Submarine Cable Project Comcast & NSTAR

**Provide redundant  
Submarine Fiber Optic Cable  
to Martha's Vineyard**

- **Comcast and NSTAR - bundle fiber optic and electric in single 5.5" diameter hybrid cable**
- **Certificate on NPC issued: August 24, 2012**
- **MEPA:**
  - **Change does not require a Supplemental EIR**
  - **Installation methods/ equipment remain unchanged**

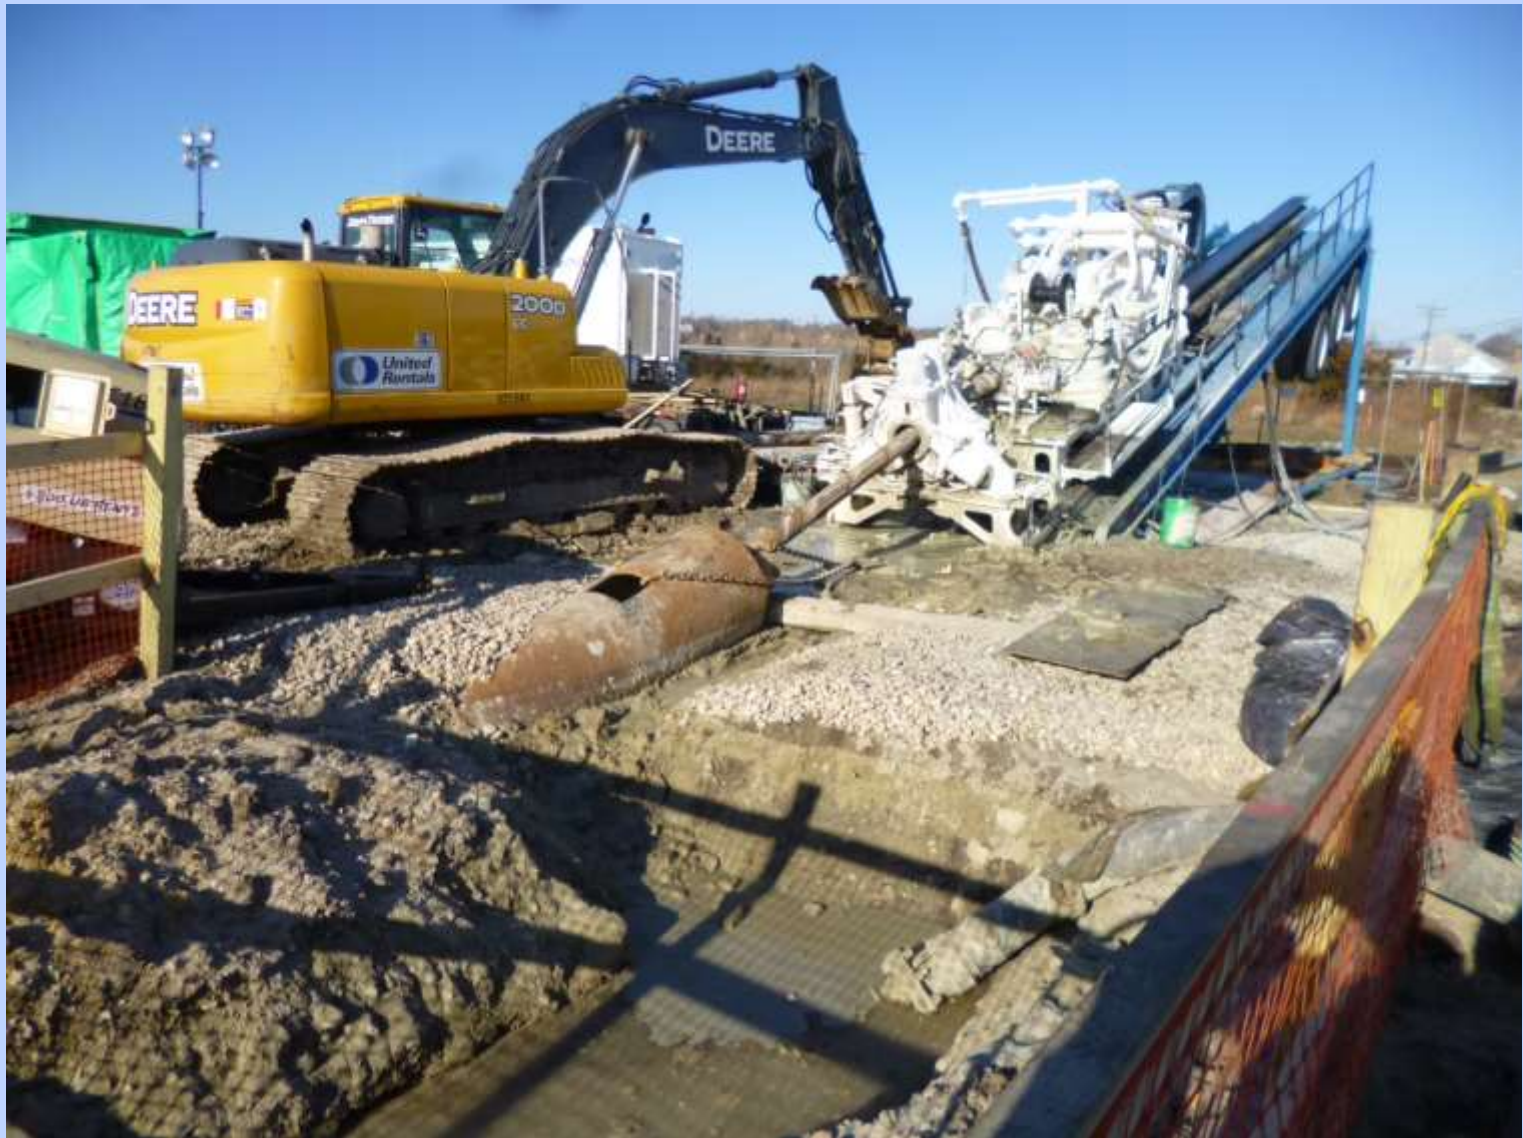
- **HDD eliminates need for open excavation through the sensitive shore and nearshore zone**
- **avoids eelgrass beds**

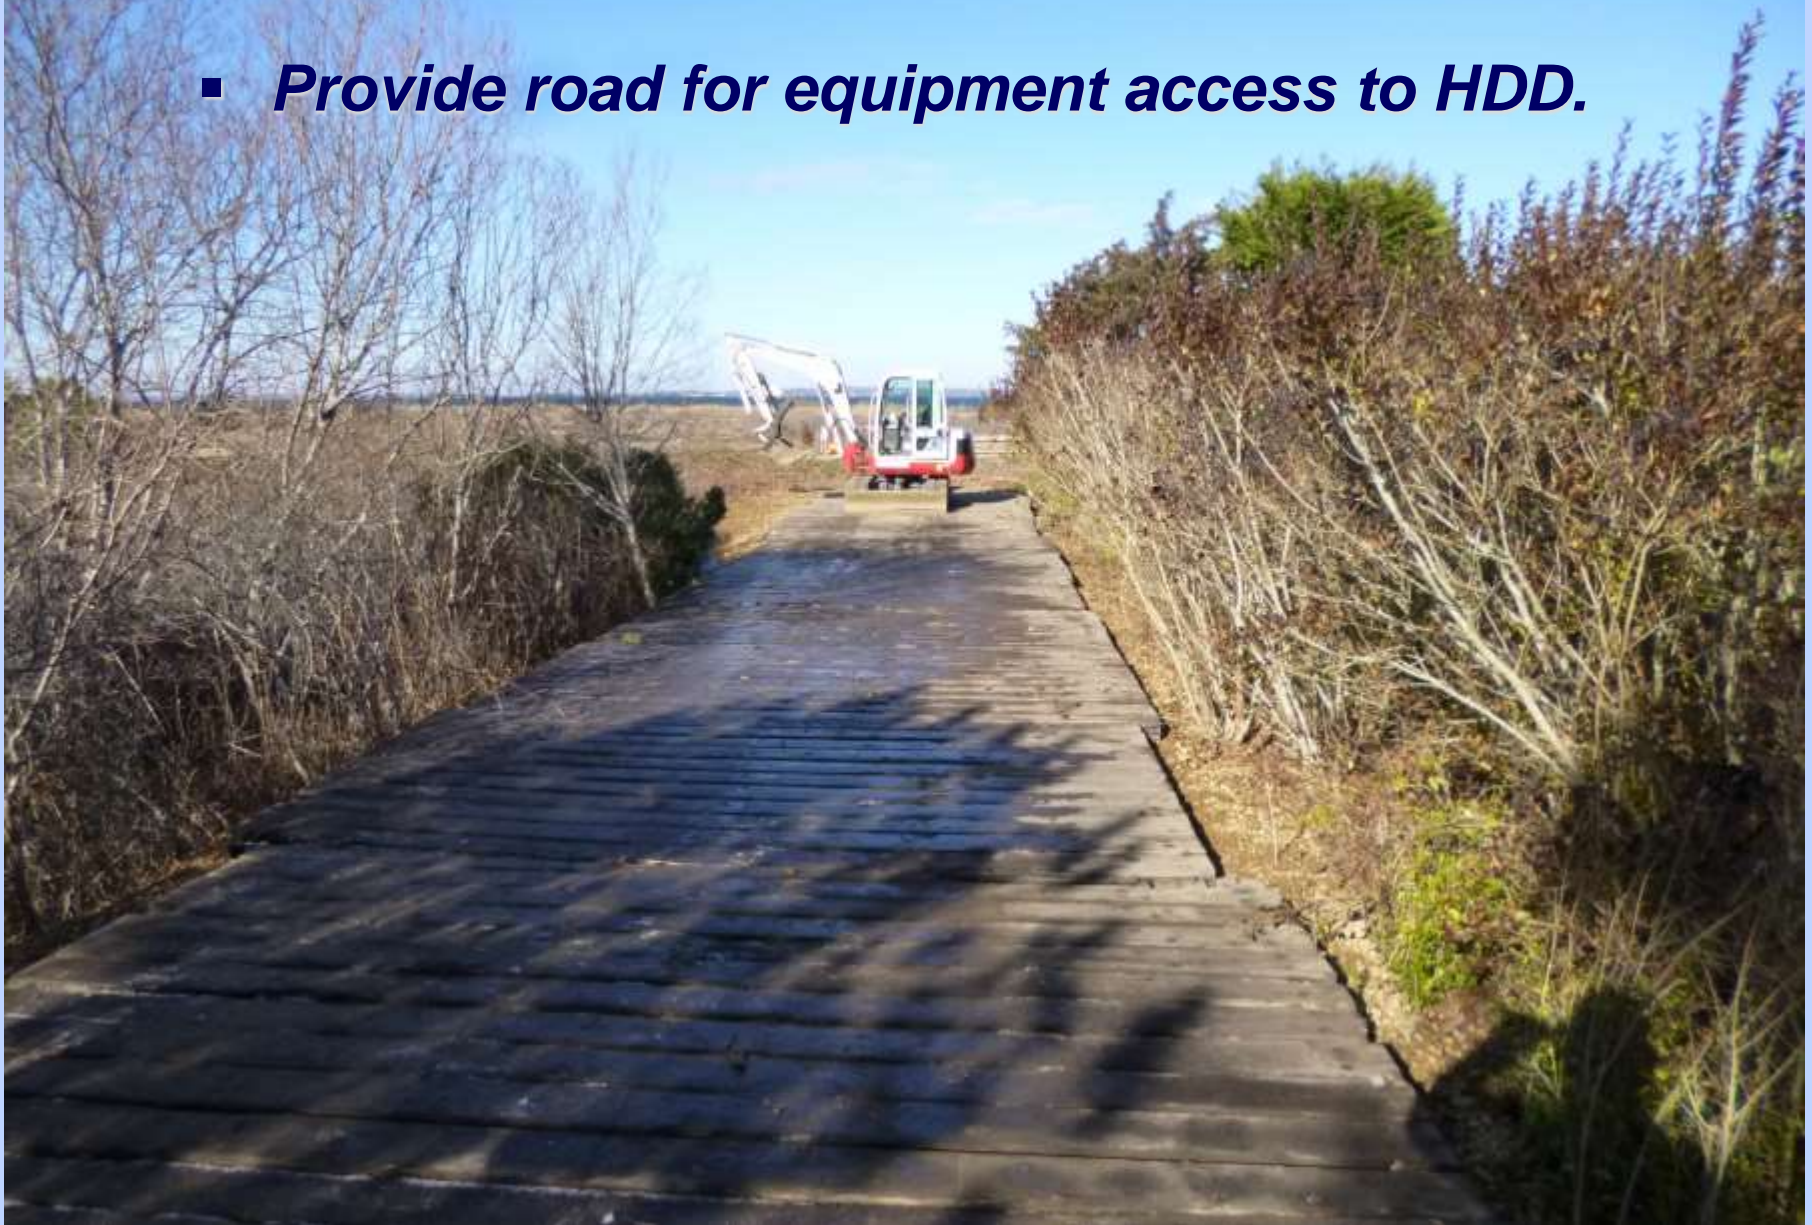
- *Provide road for equipment access to HDD.*

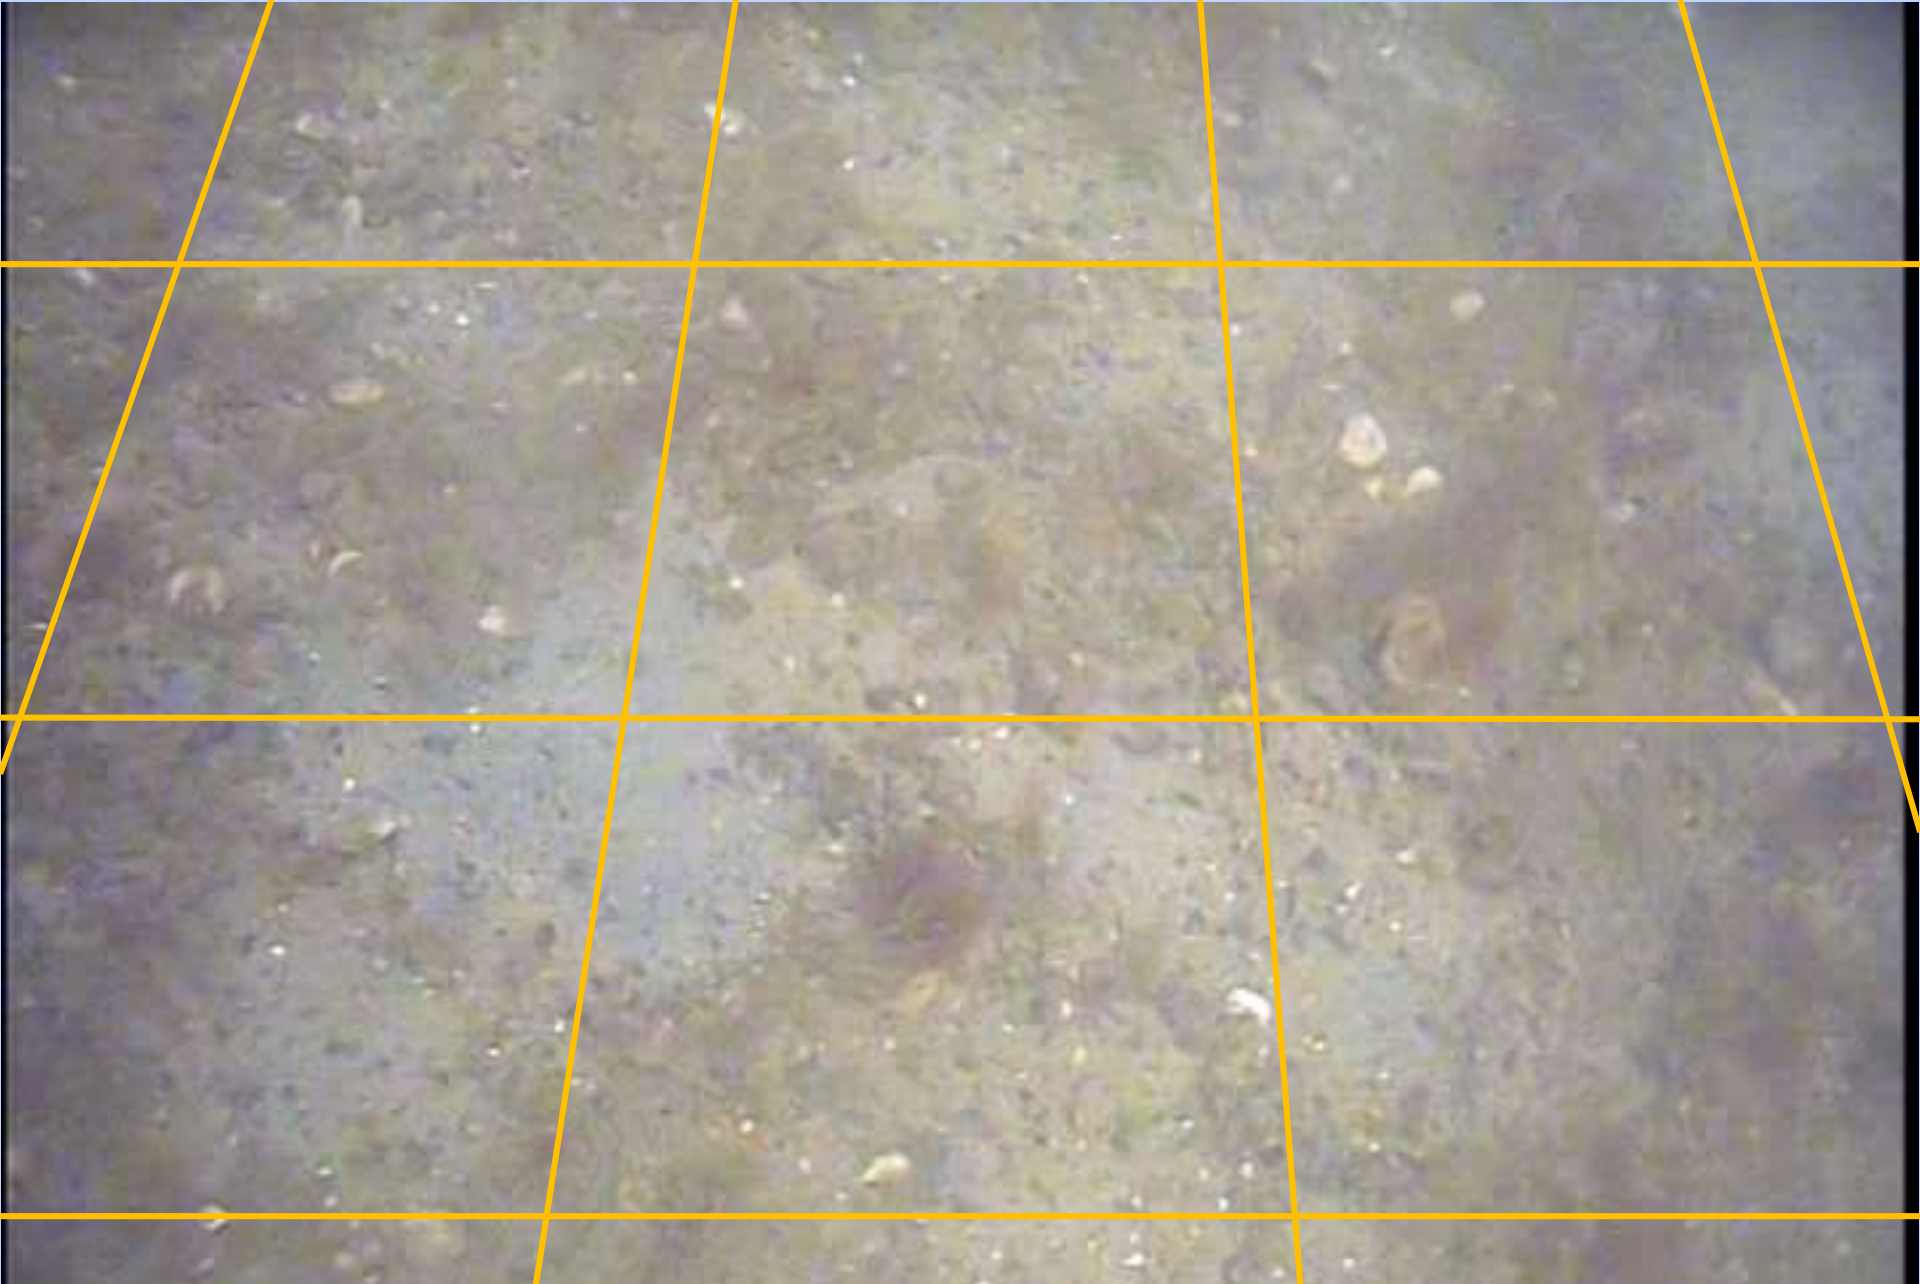
**1b (Pebble 50%, Flat Sand 50%)**

**Branching Brown & Red Algae**

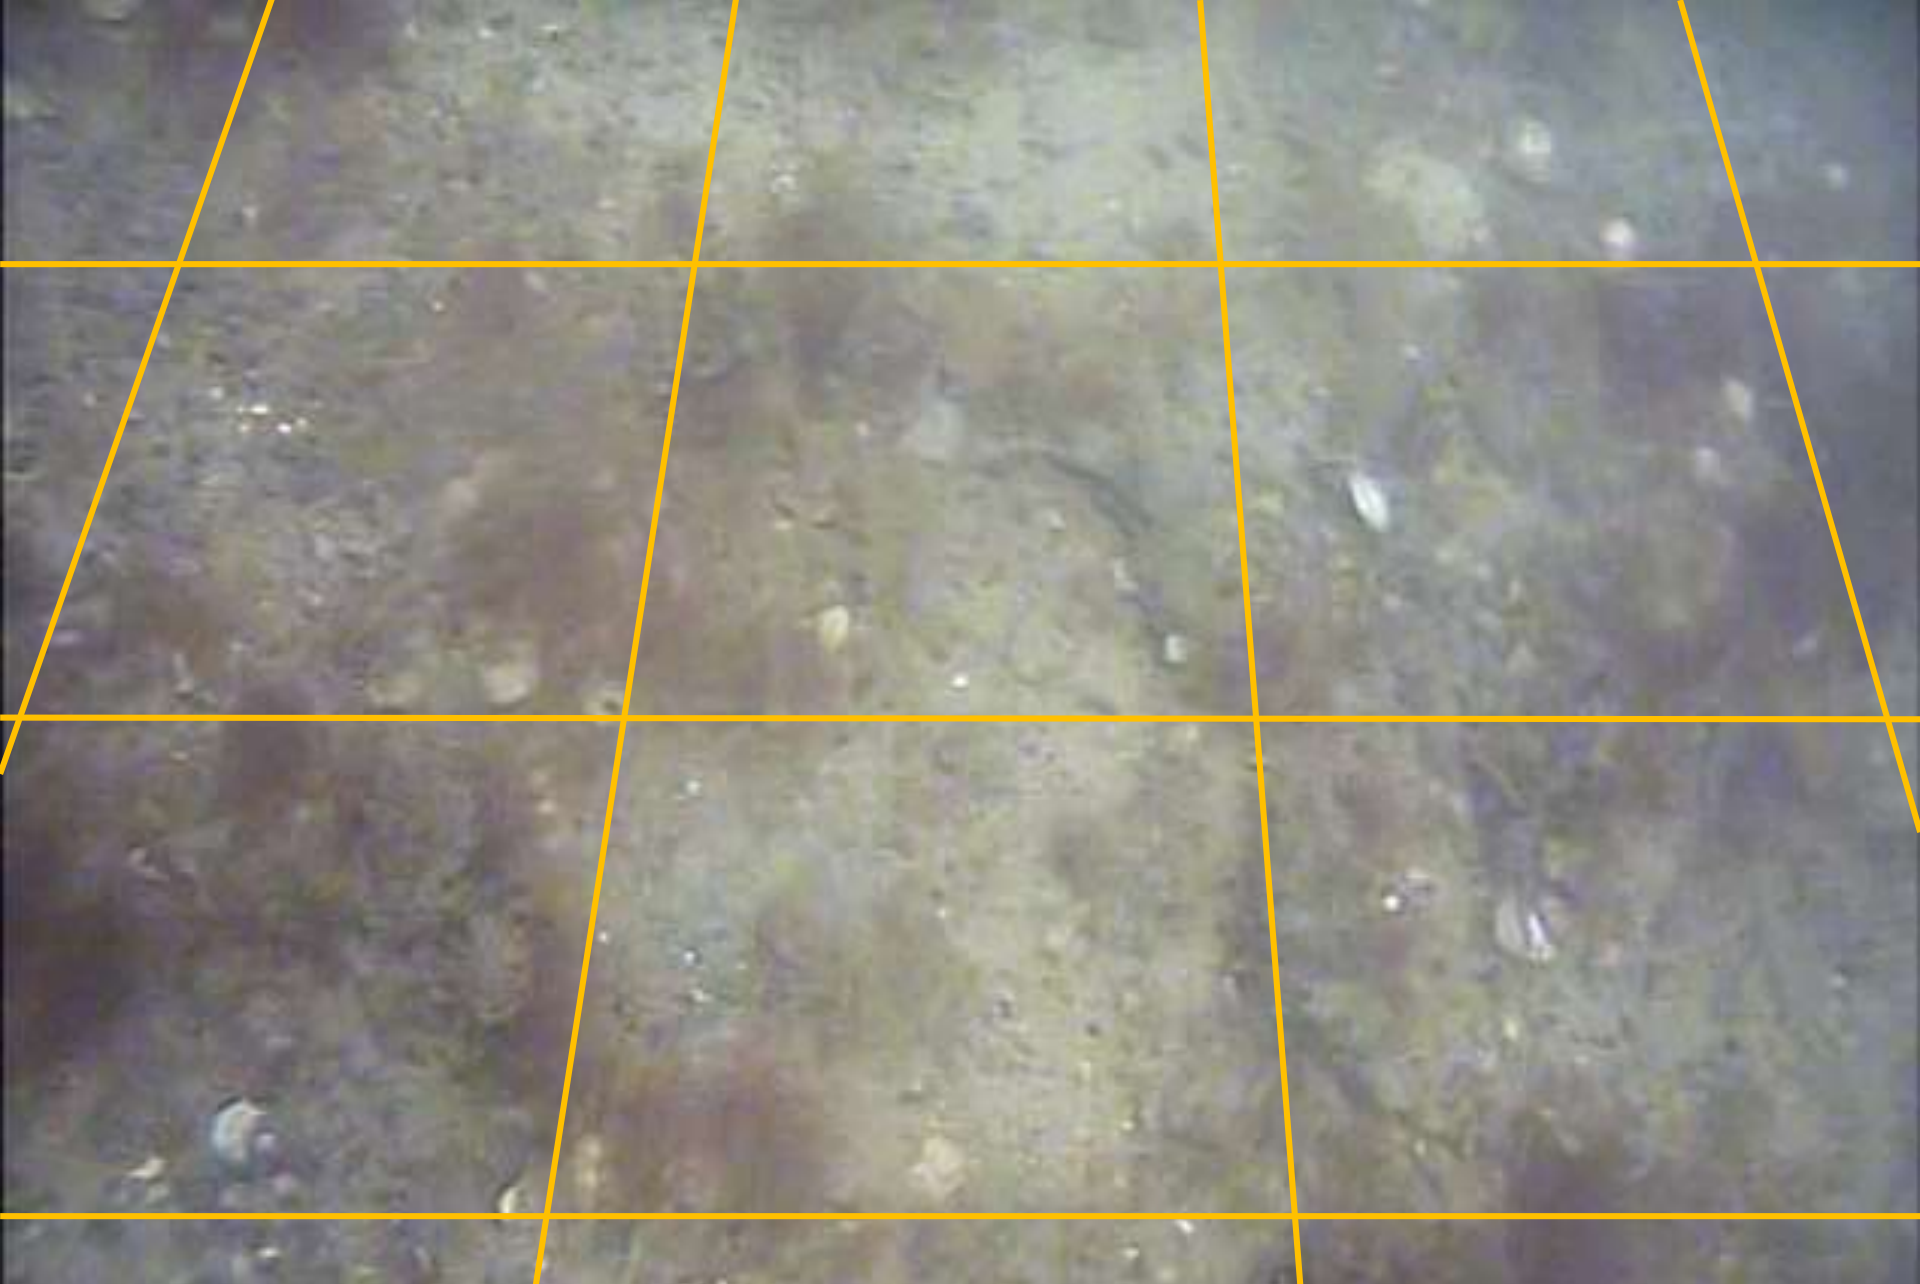
**1c HDD Crossing (Flat Sand 50%, Pebbles 50%)**

**Brown & Red Branching Algae**

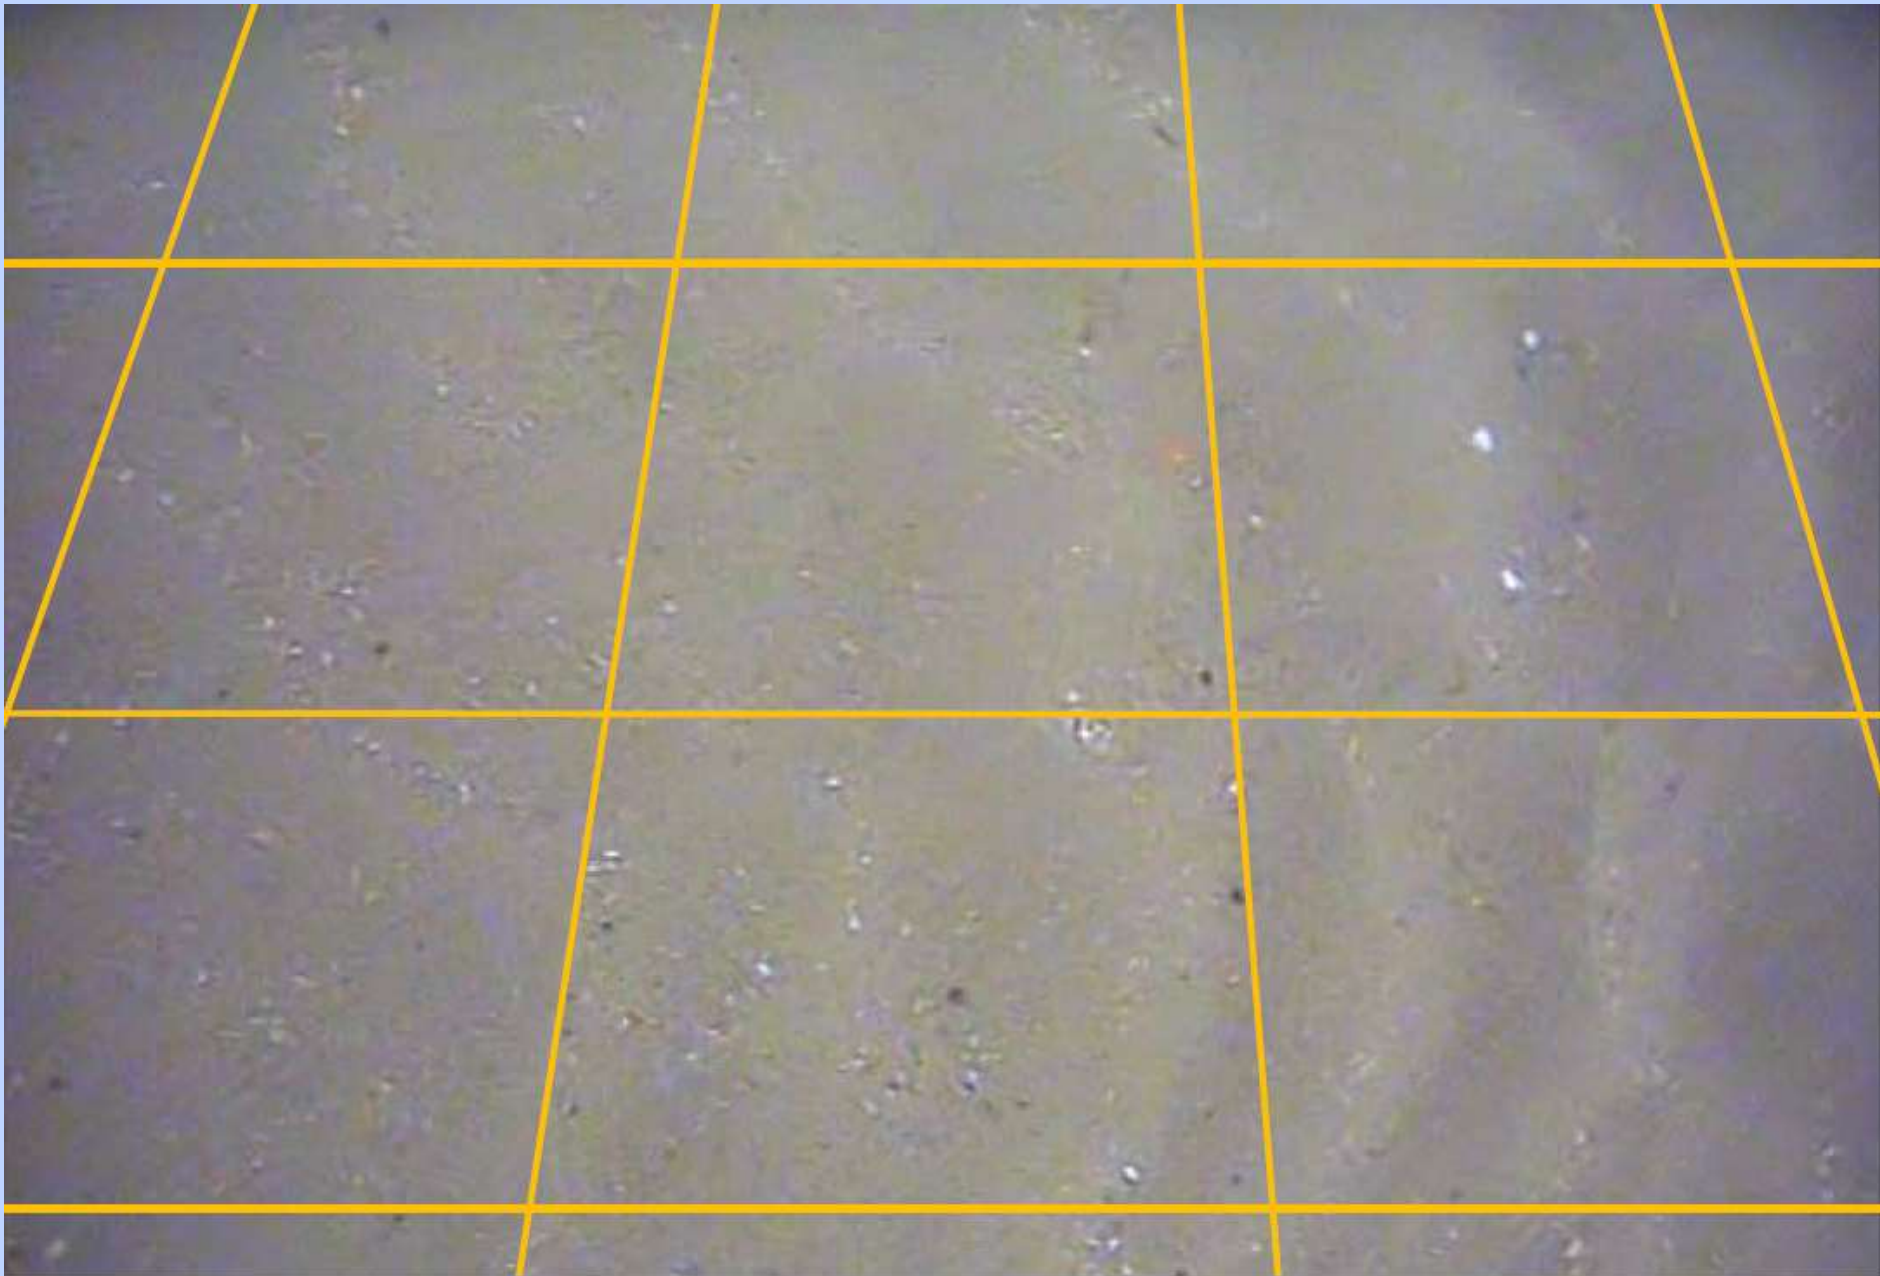
8c (Sand Waves 95%, Pebble 5%)

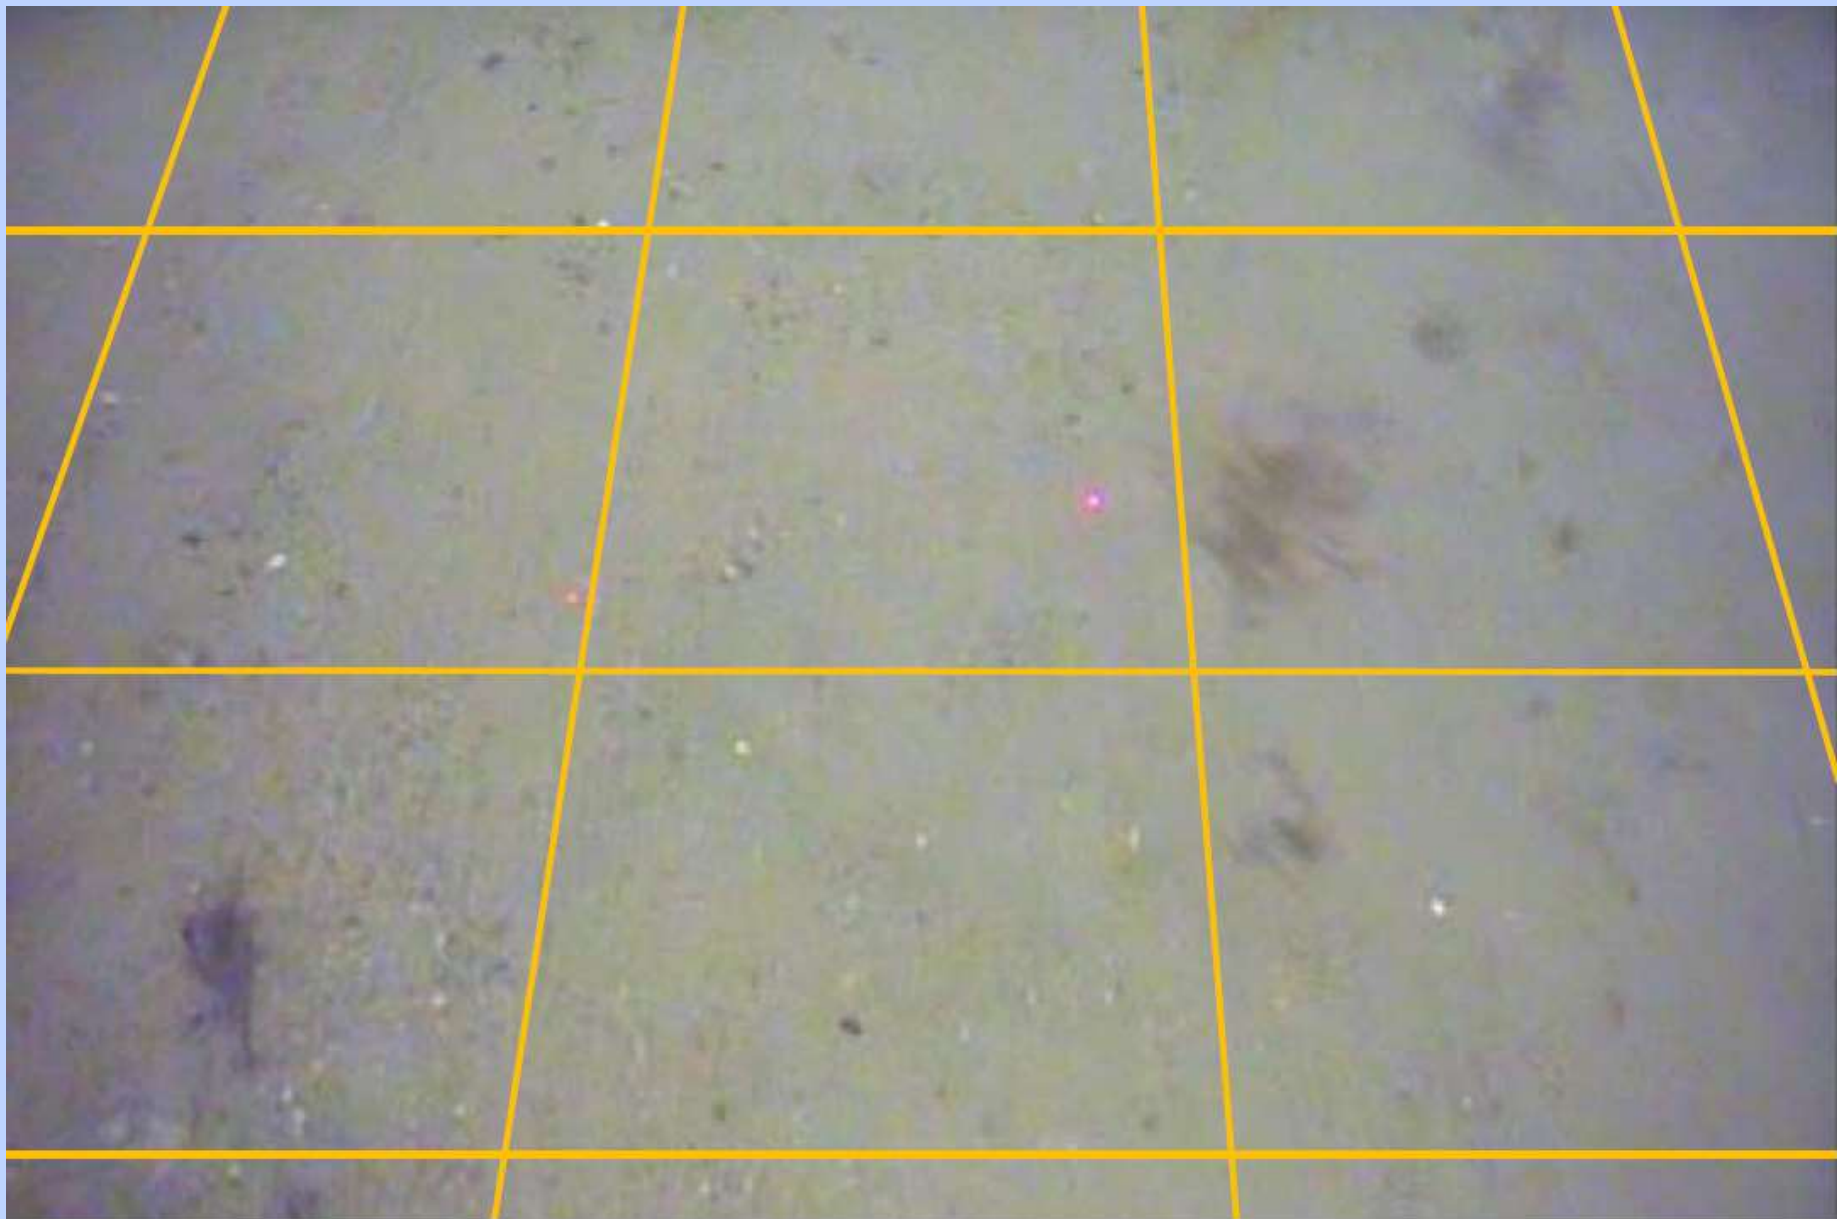
9c Plow Burial Cable Crossing (Flat Sand 95%, Pebble 5%)

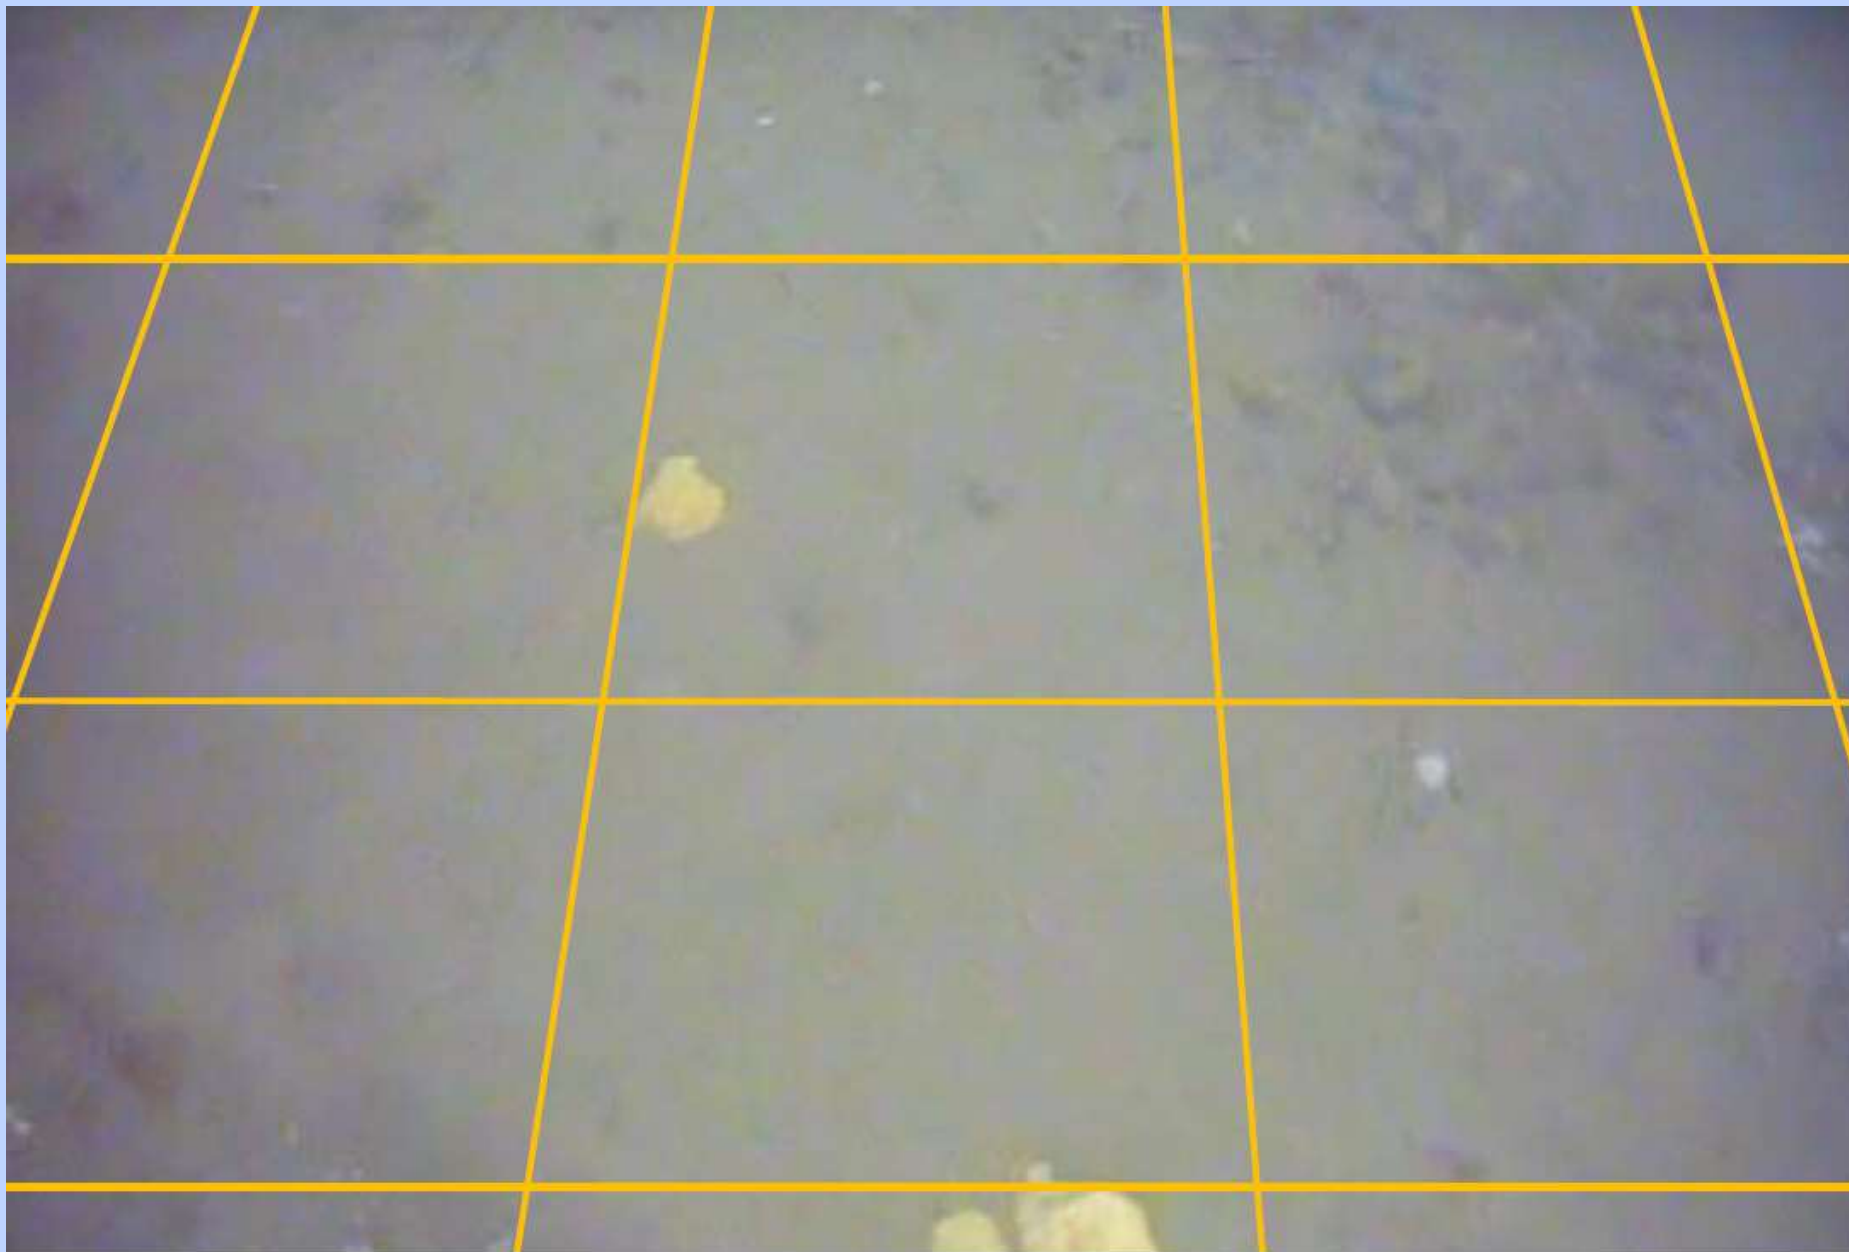
10c Plow Burial Cable Crossing (Flat Sand 80%, Pebble 20%) Sulfur Sponge

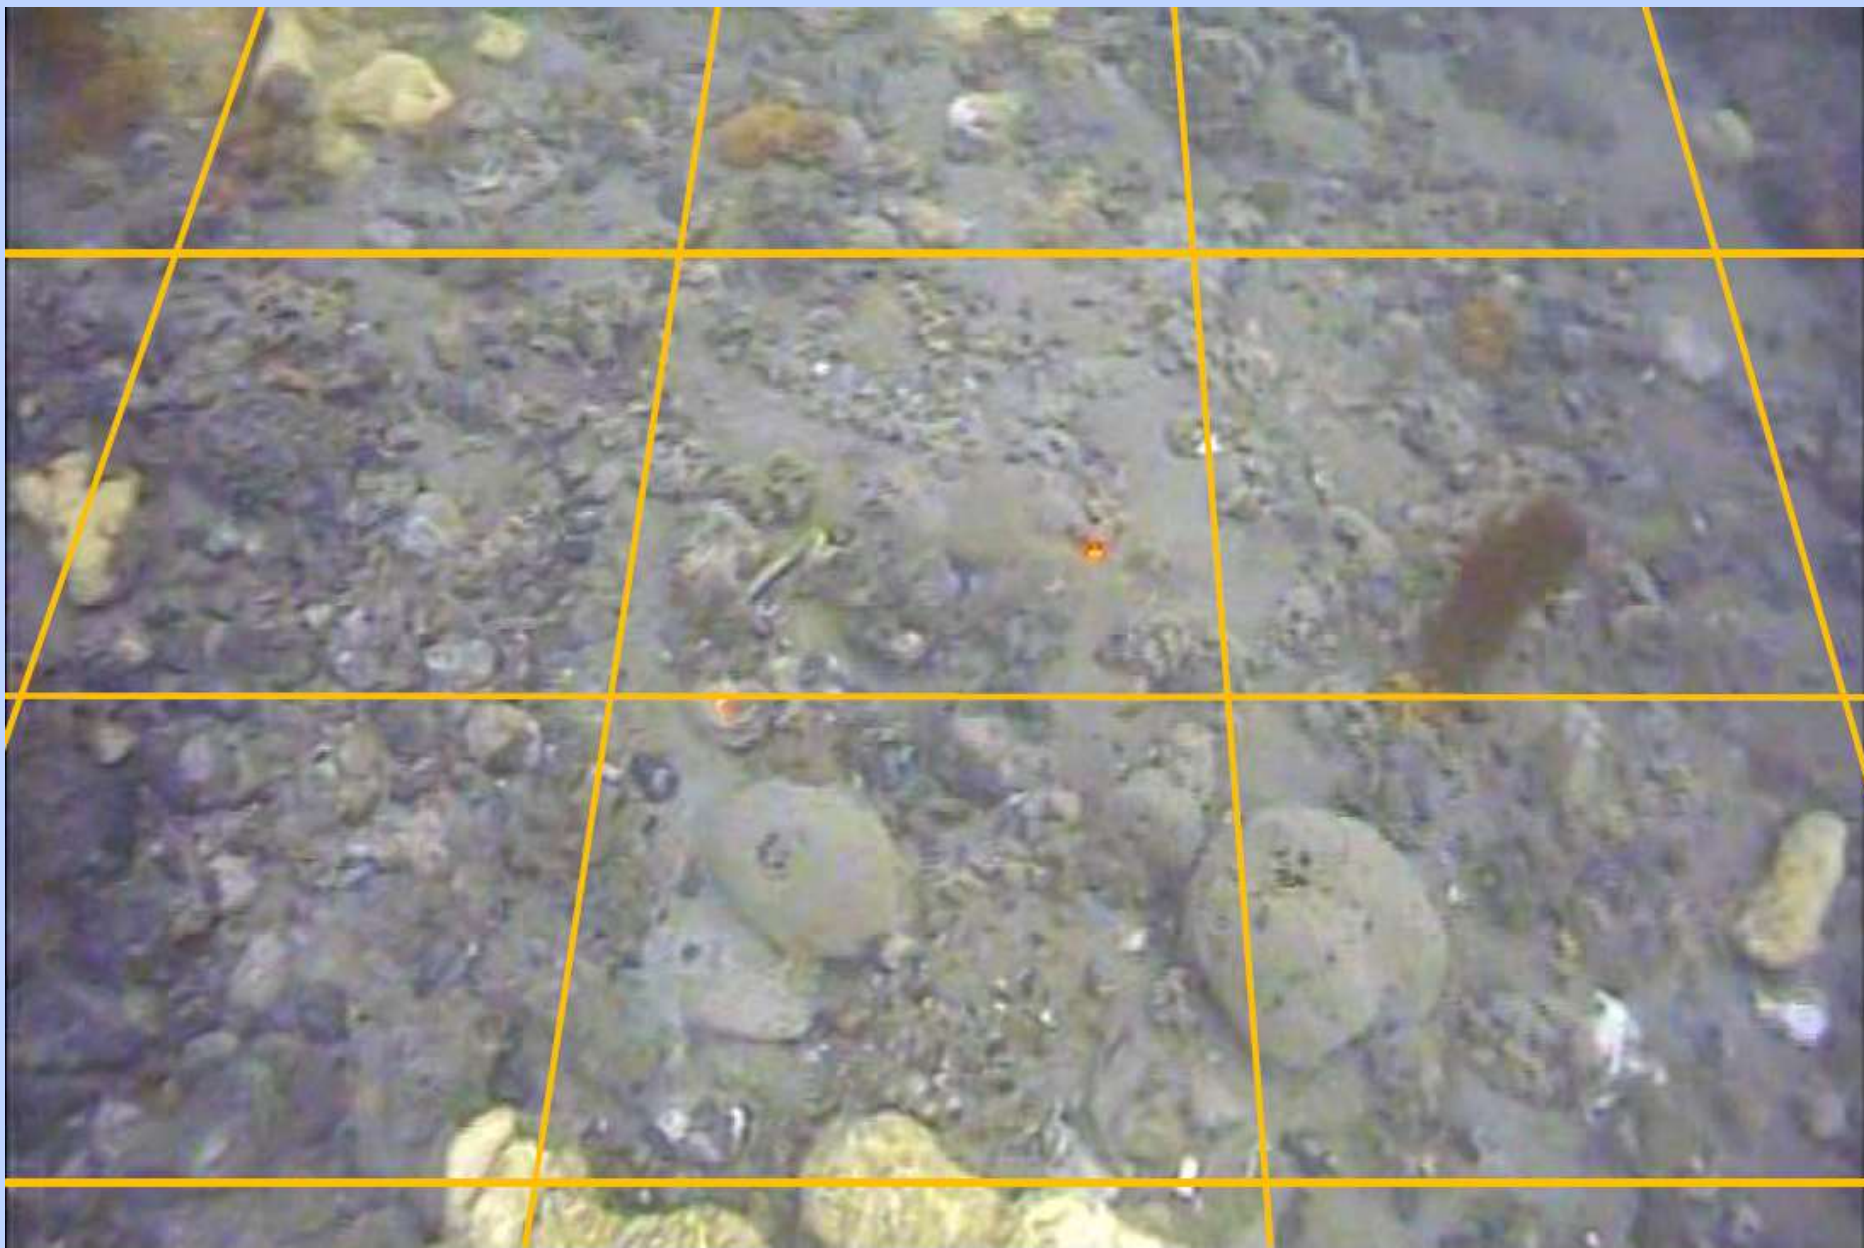
10d (Flat Sand 60%, Pebble 35%, Cobble 15%) Sulfur Sponge,  
Sand Sponge, Brown Algae
