Are dam removals on Town Brook helping river herring? How do we know?

Abigail Franklin Archer, Fisheries & Aquaculture Specialist Woods Hole Oceanographic Institution Sea Grant & Barnstable County Cape Cod Cooperative Extension aarcher@capecod.gov

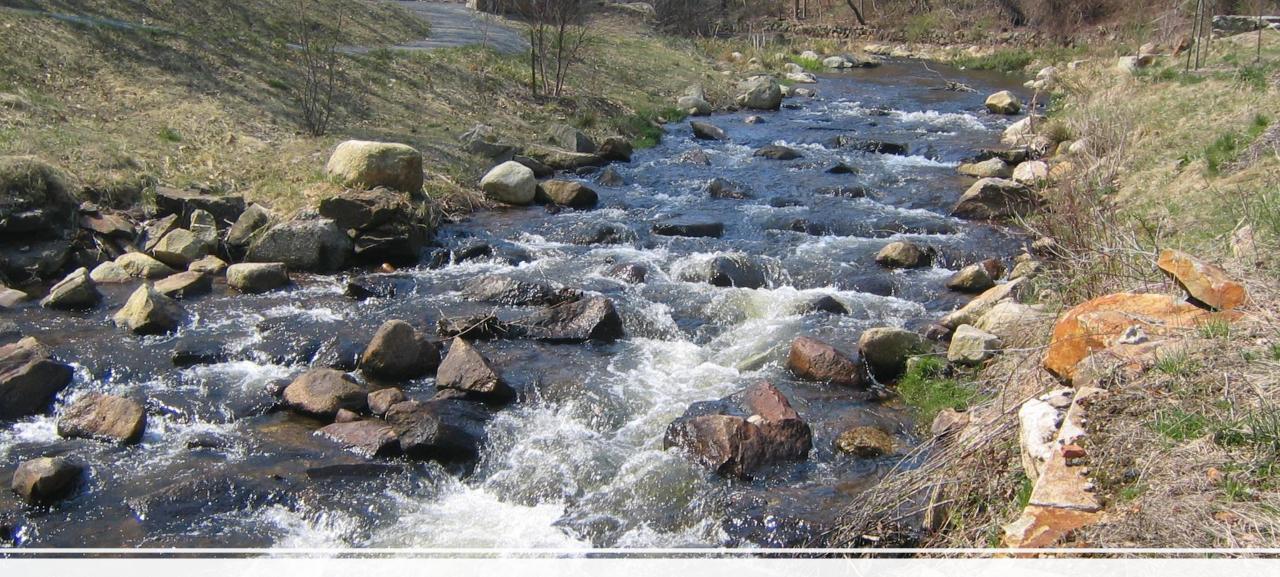
Town Brook, Plymouth – Nature-like Fish pass

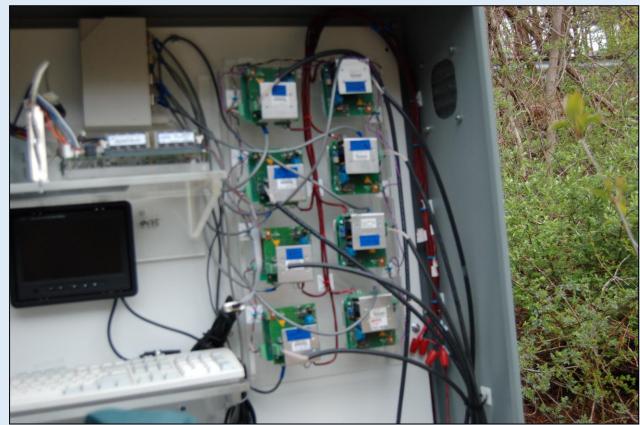
Antenna (aka Gate) Layout – Town Brook 2006

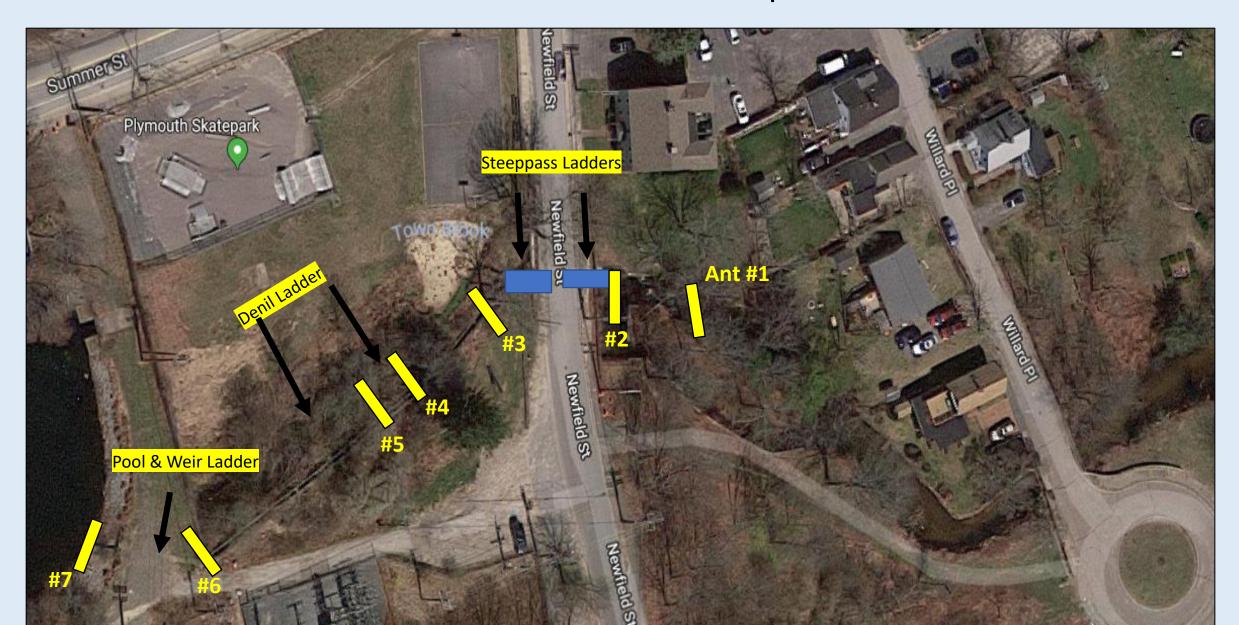
Passive Integrated Transponder Telemetry 2018 Antenna Set Up

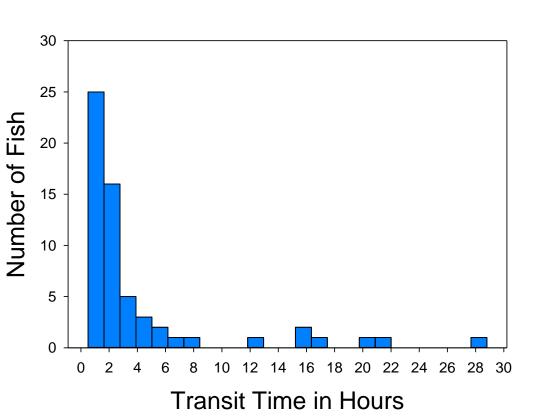
Transit Time

BEFORE

Range 30mins – 28.8 hours Median 1.87 Hours Average 4.12 Hours

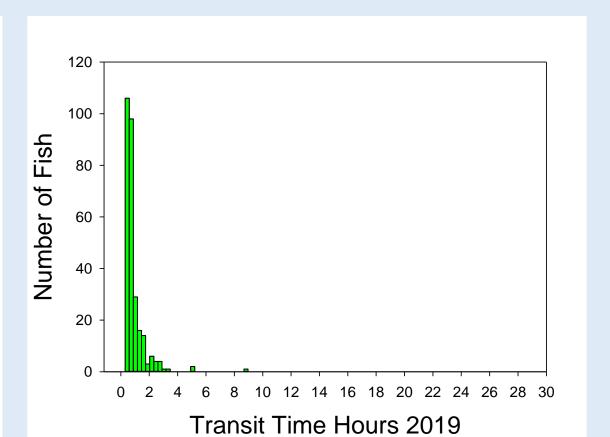
AFTER

Range 18mins – 9 hours Median 38.7 Minutes Average 53.7 Minutes

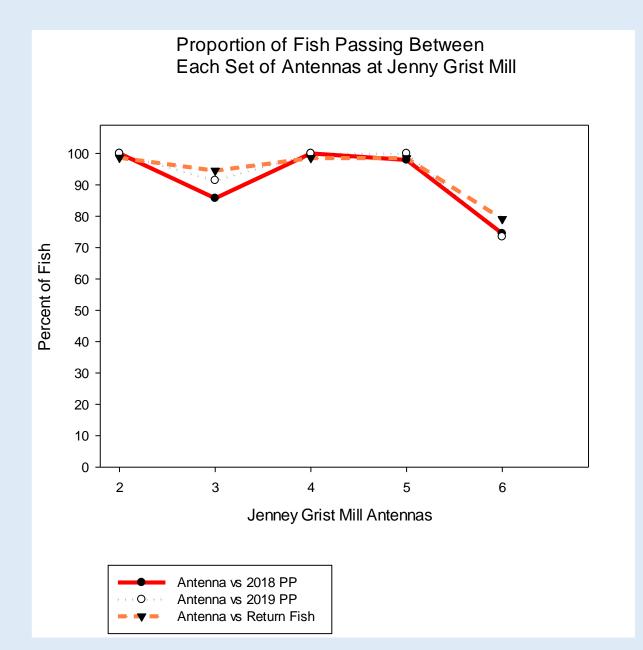
Comparison of Steeppass Percent Passage – 3 sets of fish

2018

95% CI 46.8 - 73.5

2019

95%CI 62.3 - 83.1

Return Fish

95% CI 60.9 - 82.4
