Erosion and Retreat at Monomoy National Wildlife Refuge

Islands Coastal Conference 2024
Martha's Vineyard 10/01/2024

Morris Island Bluff – Feb 2021

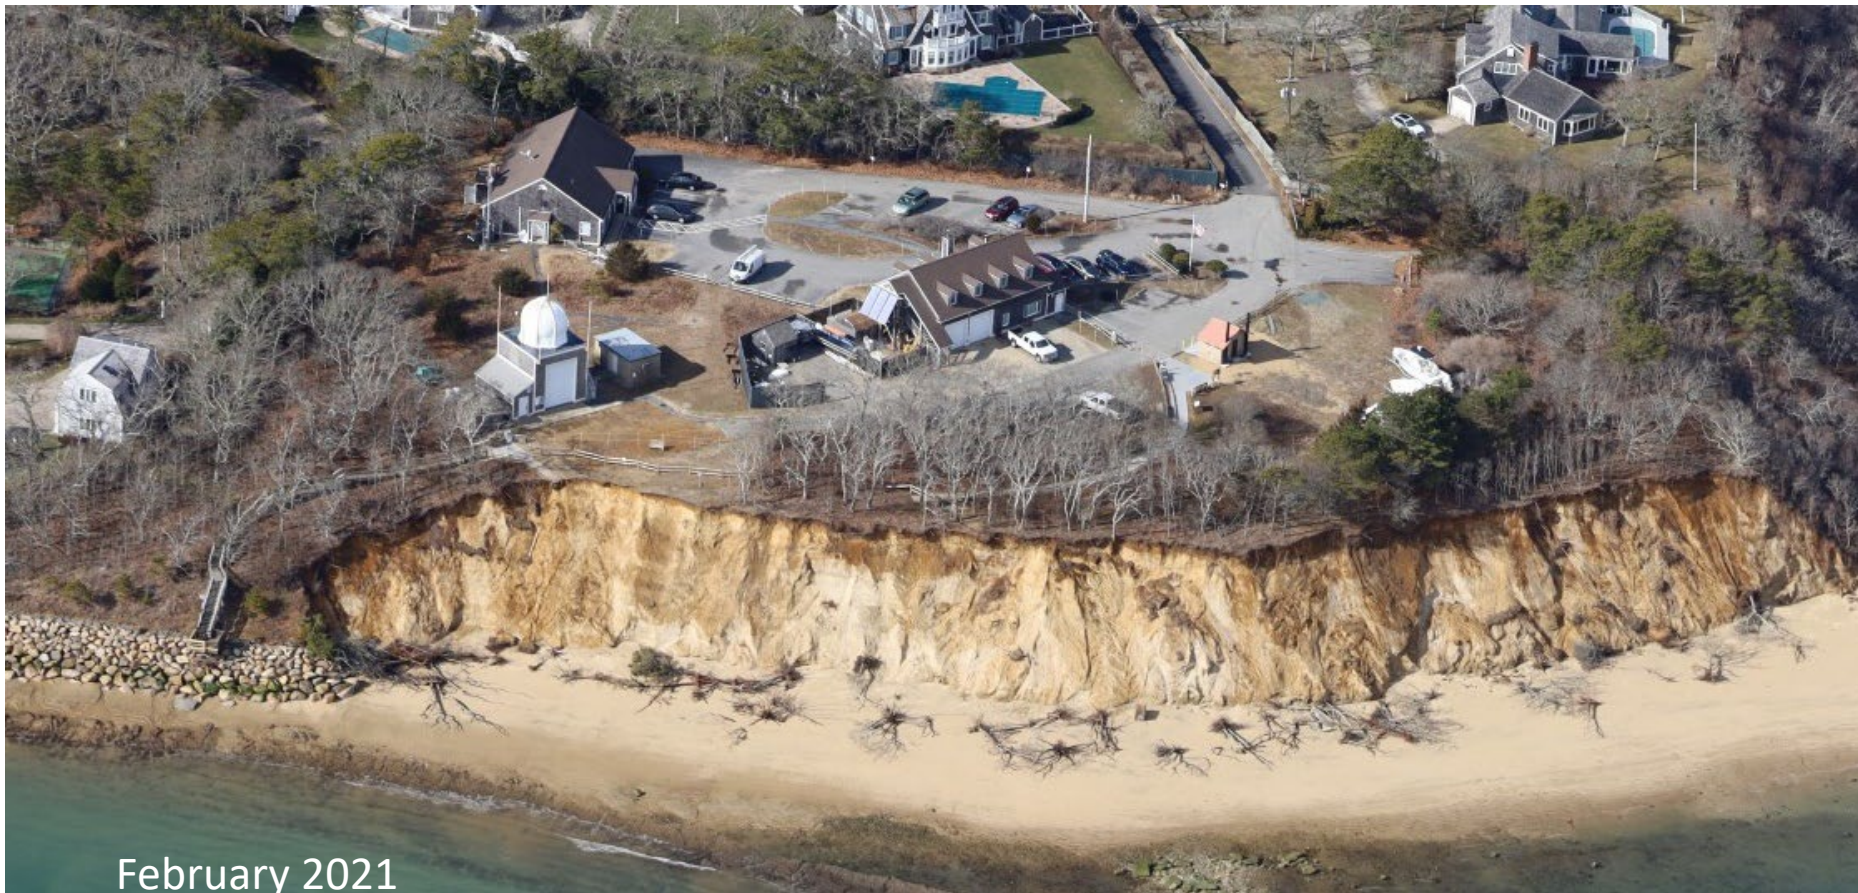
February 2021

Loss at top of bluff

- 20 to 55-ft lost since 2017
- 1/2 Acre off the top in 4 years
- 12 Transects since Nov 2020
- 5-ft of loss from Nov - Feb
- 7-ft/year mean loss by 2021

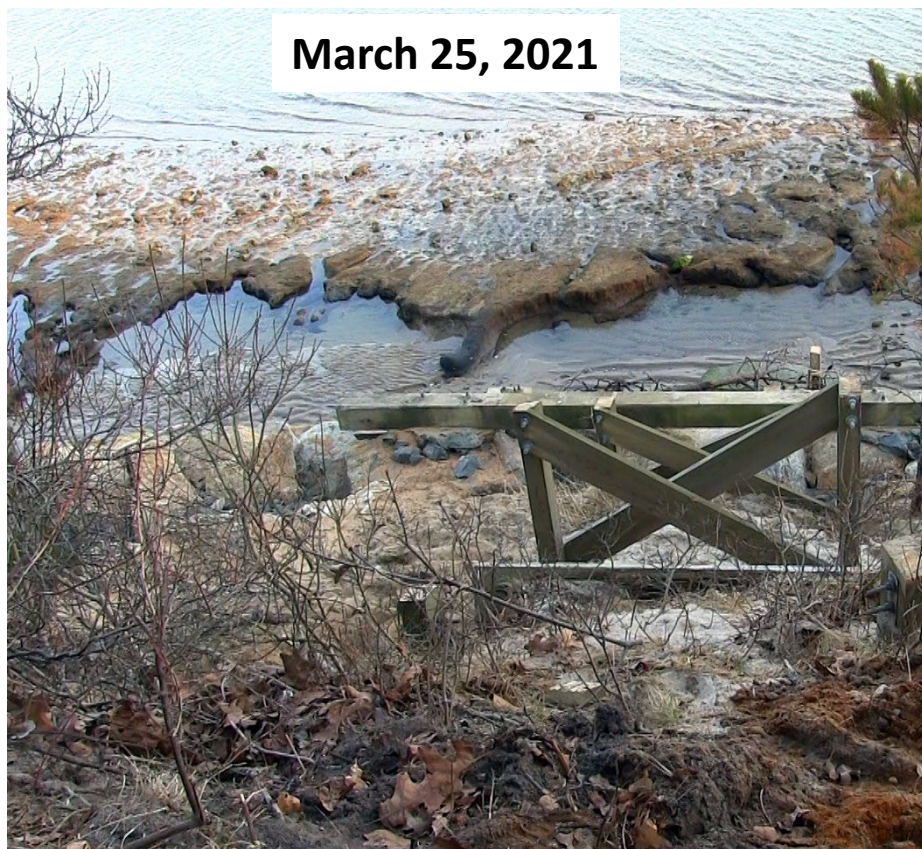
Morris Island Bluff Erosion – Facilities Removal

- Bottom half stair removed Nov 2020
- Remainder removed in Mar 2021
- Northern access closed at platform

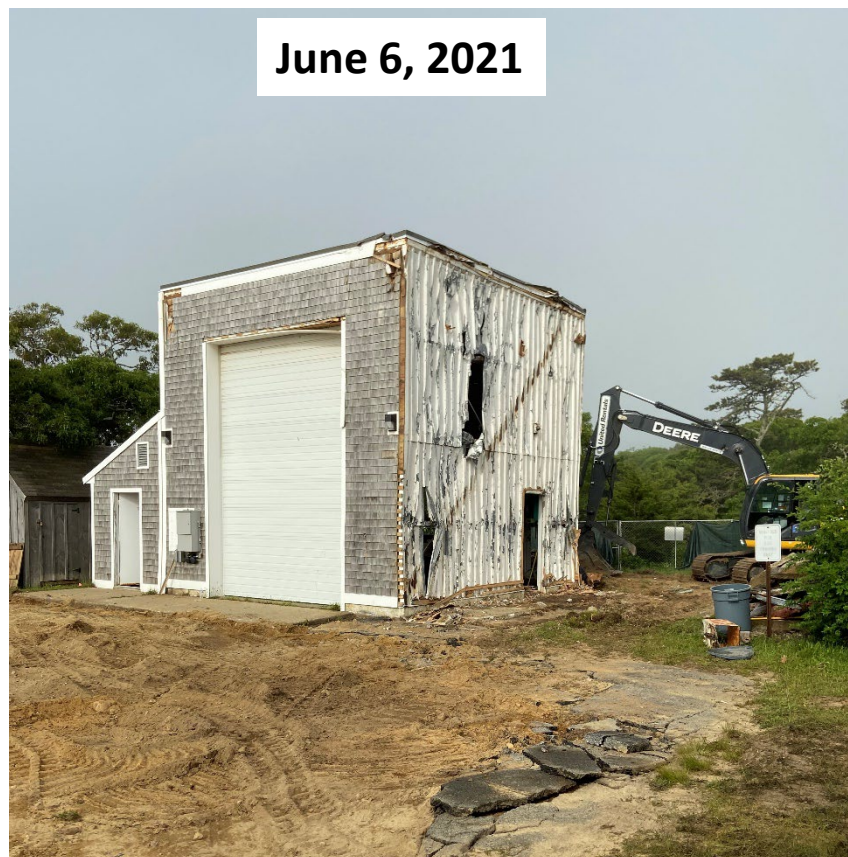
- Weather station demolished June
- Storage sheds relocated

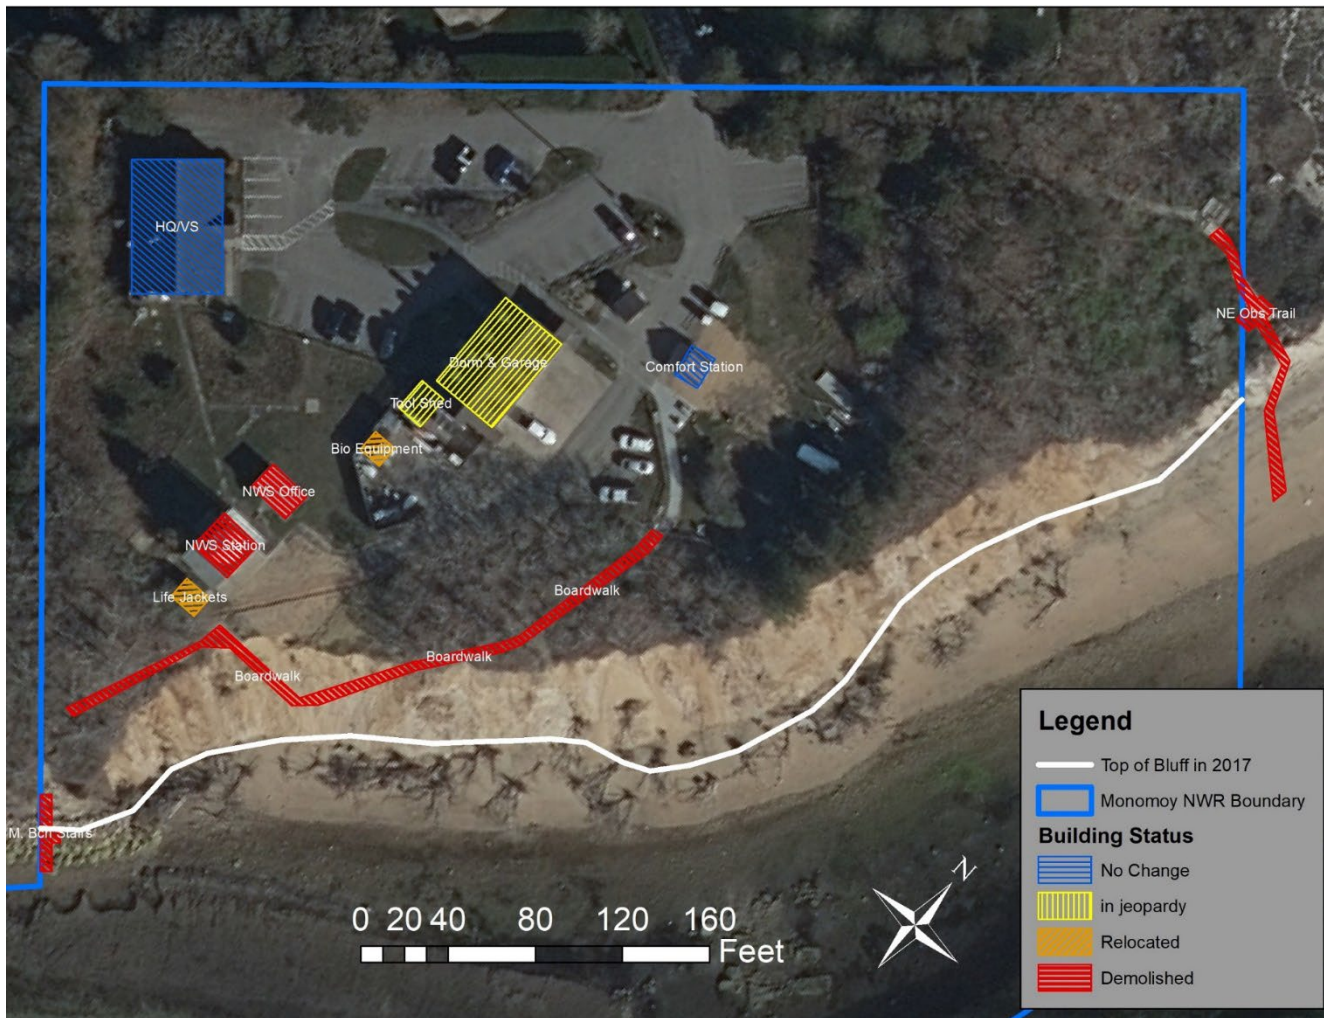
Morris Island Bluff Erosion – Site Plan 2021

Dorm / Maint.
shop in jeopardy

- Space for 10 interns
- Plus 4 temporary stays
- 1.5 bay garage

- Dorm is 102 feet from edge
- At 85-ft: no equipment between dorm and bluff
- At 50-ft: no dorm use

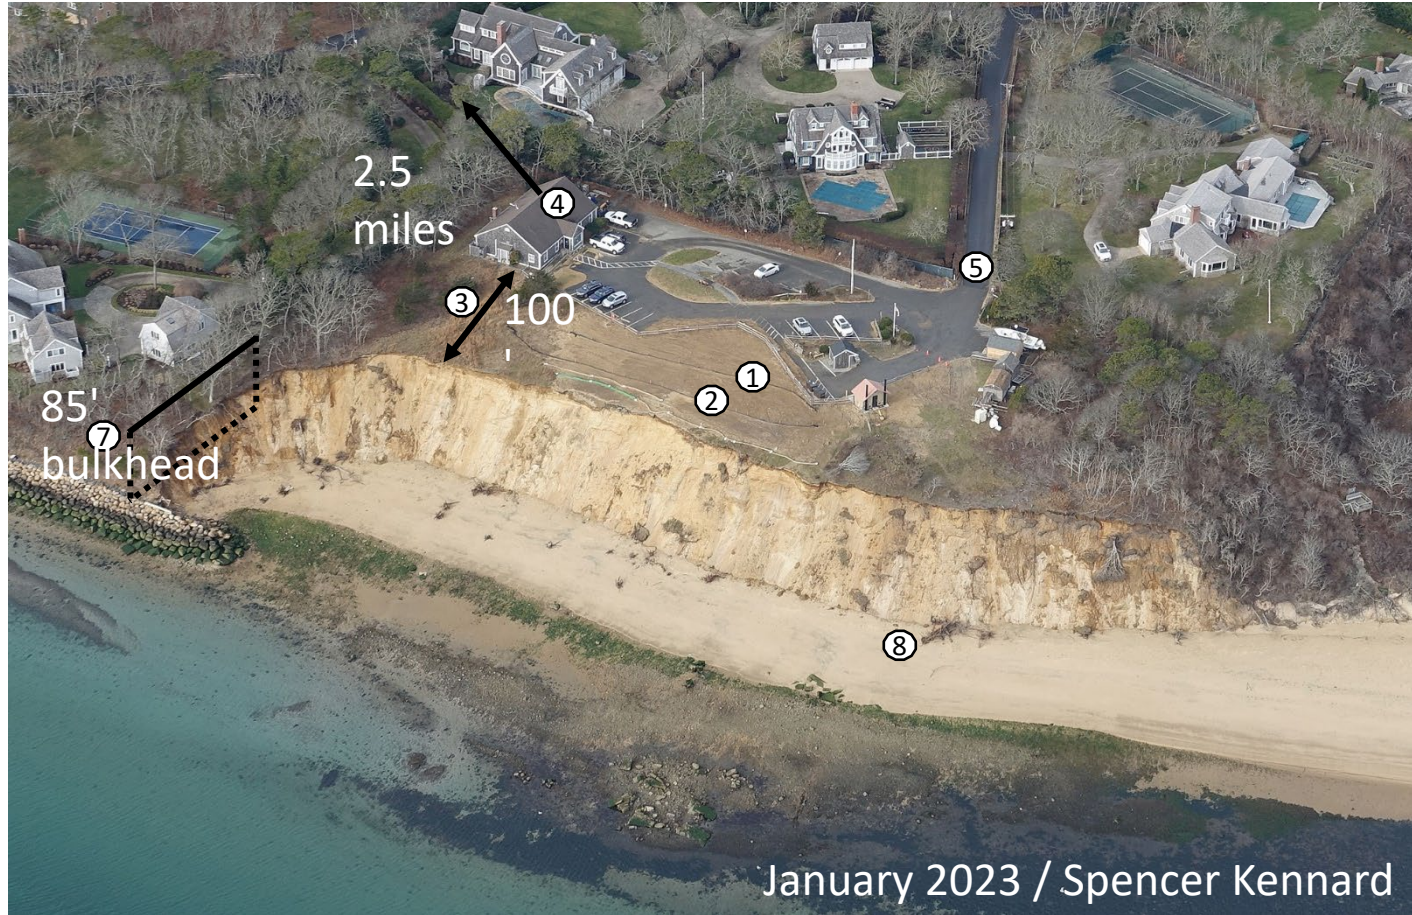
Morris Island Bluff Erosion – January 2023

Facilities

- Dormitory demolished ①
- Maintenance demolished ②
- HQ/VC 100' from edge ③
- Acquisition/Relocation? ④

Access ⑤

Neighbors & Community ⑥

Revetment / bulkhead ⑦

Trees ⑧

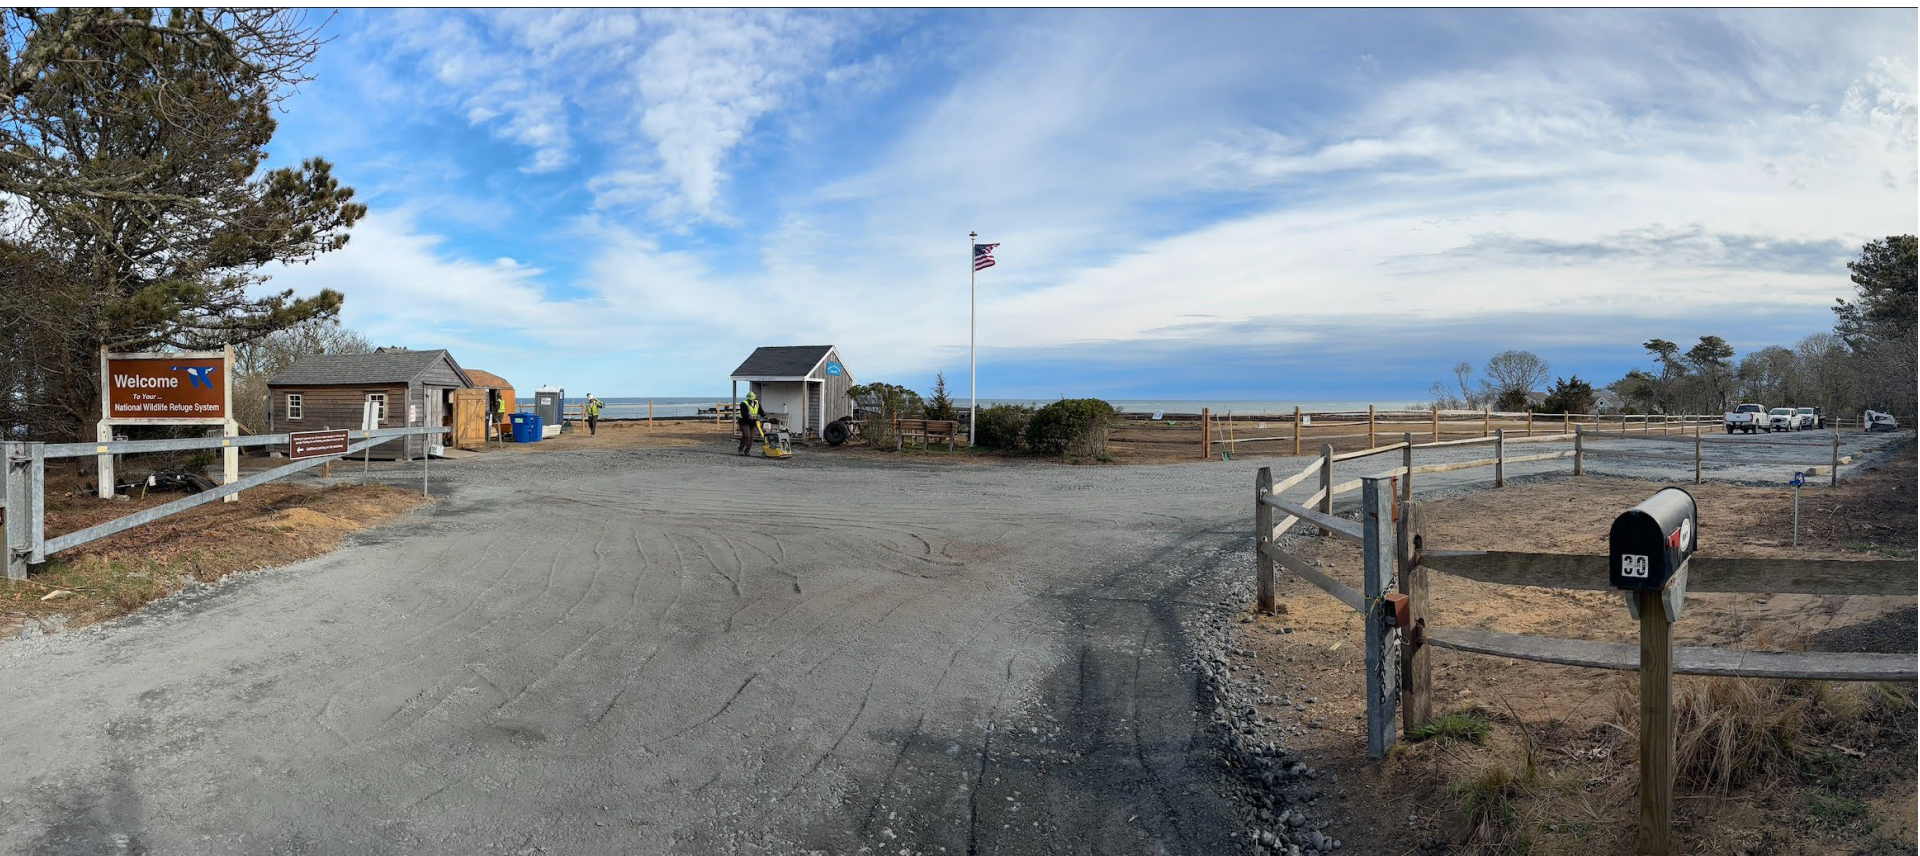
Remaining Facilities

Sheds – easily removed / relocated

Parking area with natural materials

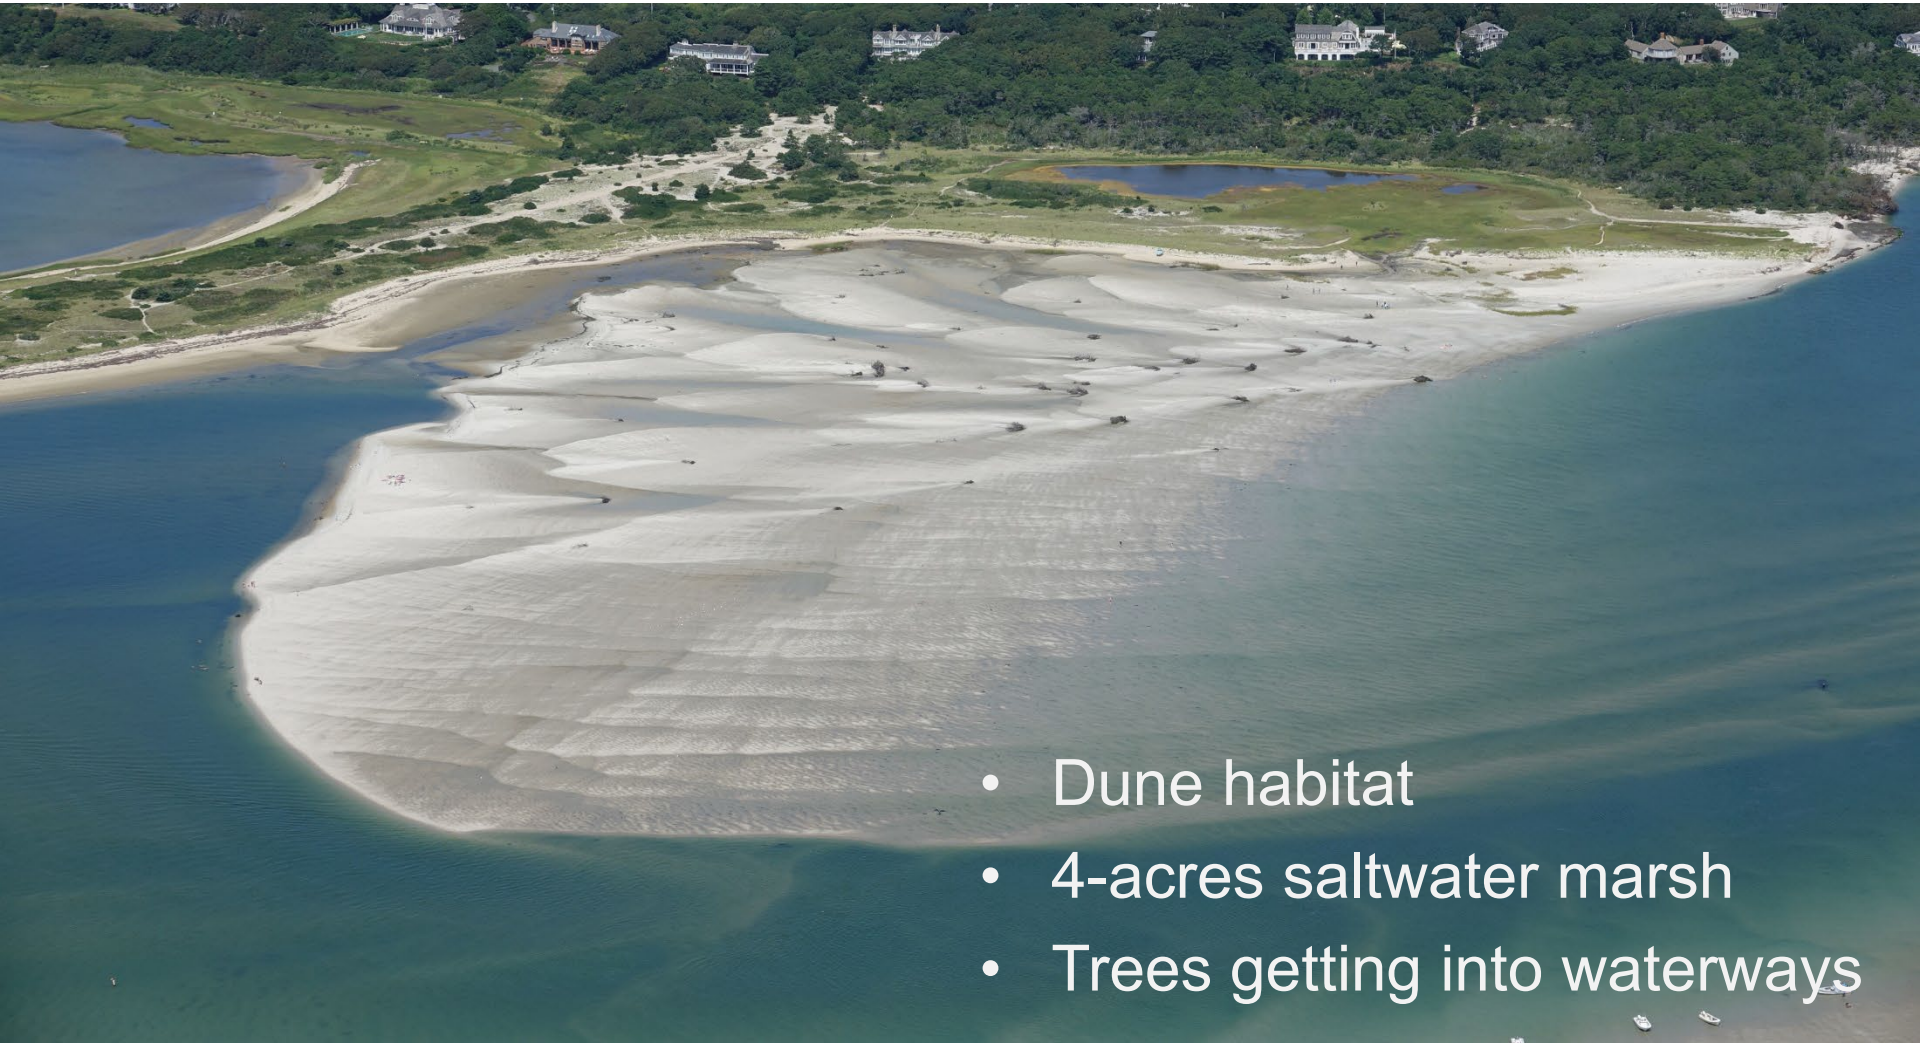
Critical Habitat on Morris Island

- Dune habitat
- 4-acres saltwater marsh
- Trees getting into waterways
