Benefits to Coastal Resilience from Restoring a Freshwater Wetland Complex at Windswept Bog, Nantucket, MA

Karen Beattie, Vice President of Science & Stewardship

Department of Ecological Research, Stewardship & Restoration Nantucket Conservation Foundation, Inc. **Mission:** The Nantucket Conservation Foundation owns, protects and stewards over 9,000 acres of land and coastal shoreline, conserves Nantucket's rare and significant natural resources, and engages in impactful ecological research to inform resource management and further our knowledge of Nantucket's unique ecosystems and species. We share our environmental expertise with the wider community and provide educational and recreational opportunities to encourage respectful enjoyment and appreciation of our properties.

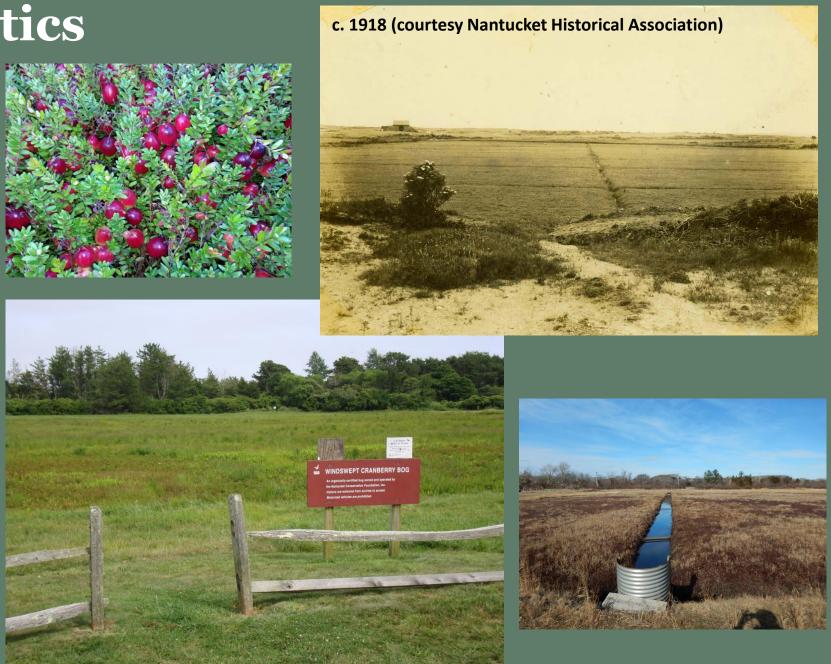
- Windswept is a former cultivated cranberry bog constructed in early 1900's
- Property purchased by NCF in 1980:
 - 40 acres in 14 individual cultivated bog cells
 - 110 acres of natural wetlands
 - 81 acres of uplands
- Cranberry cultivation was retired in 2017

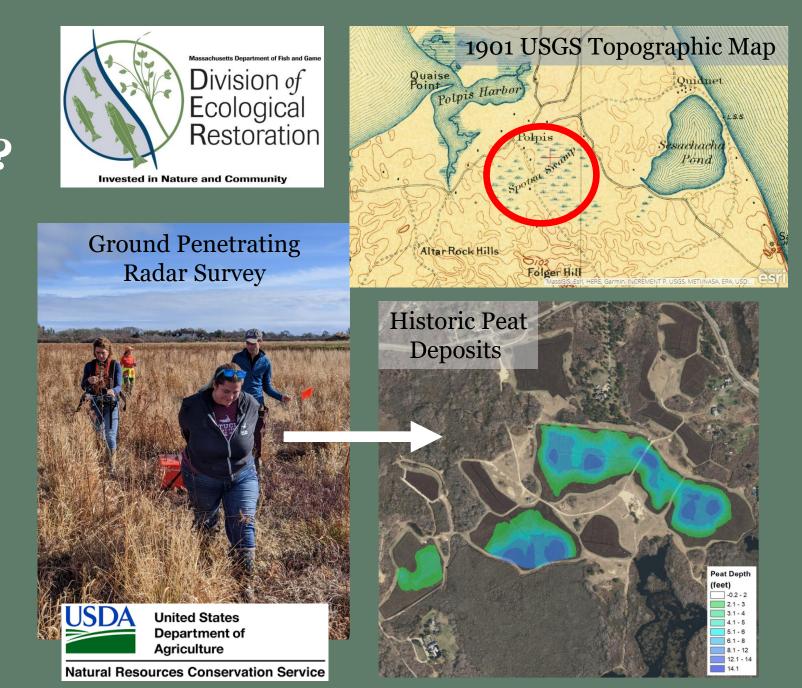
- Ground penetrating radar survey detected 2-14 ft of underlying peat, confirming historic wetlands
- Partnership with Mass. Division of Ecological Restoration Cranberry Bog Program
- Windswept accepted as a "Priority Project" with MassDER in 2021

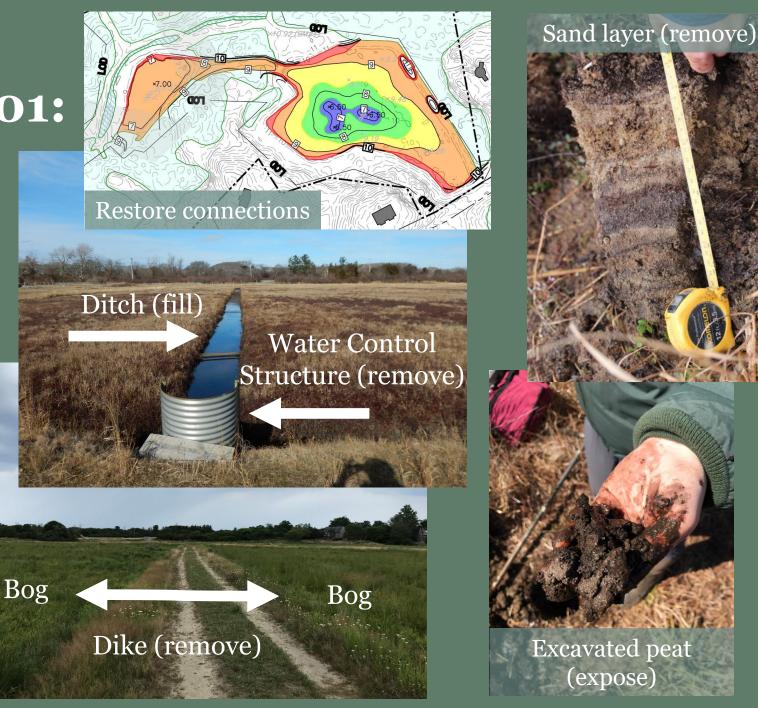
WINDSWEPT BOG WETLAND RESTORATION EXISTING CONDITIONS

- Remove dikes, berms and water control structures to restore connections and natural flow
- Remove sand layer to reduce elevation and reconnect with groundwater
- Use the sand to fill ditches to reduce channelization and create natural topography
- "Roughen" the bog surface to expose peat and wetland plant seed bank

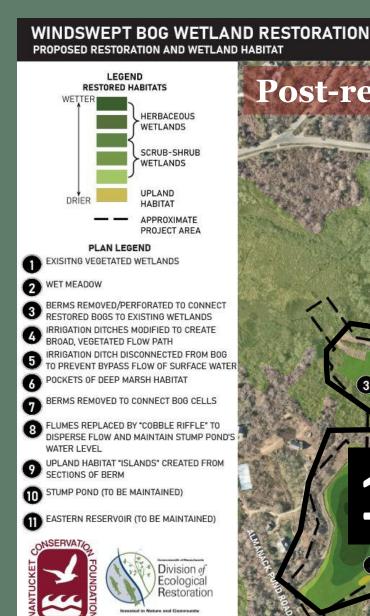
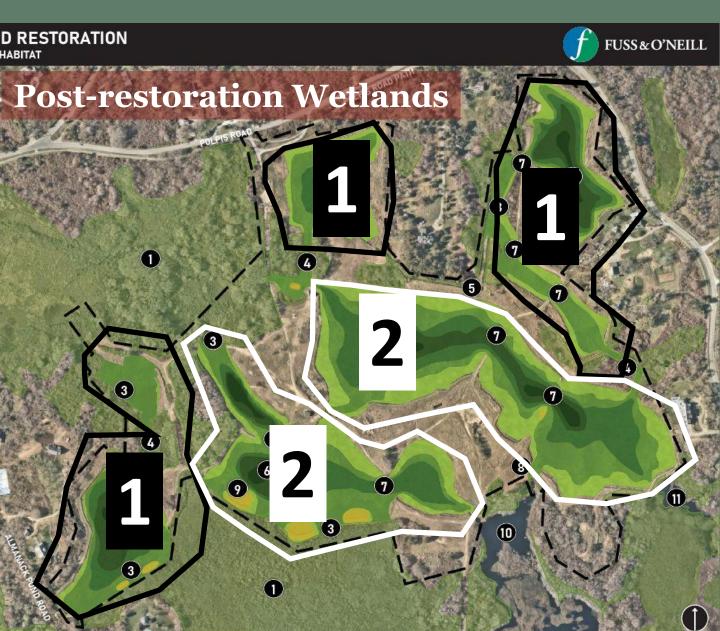
Wetland Restoration Design, Timeline and Phasing

- Jan. March 2024: Phase 1 construction
- April Oct. 2024: Inter-phase monitoring
- Nov. 2024 -March 2025: Phase 2 construction
- April 2025: Project completion

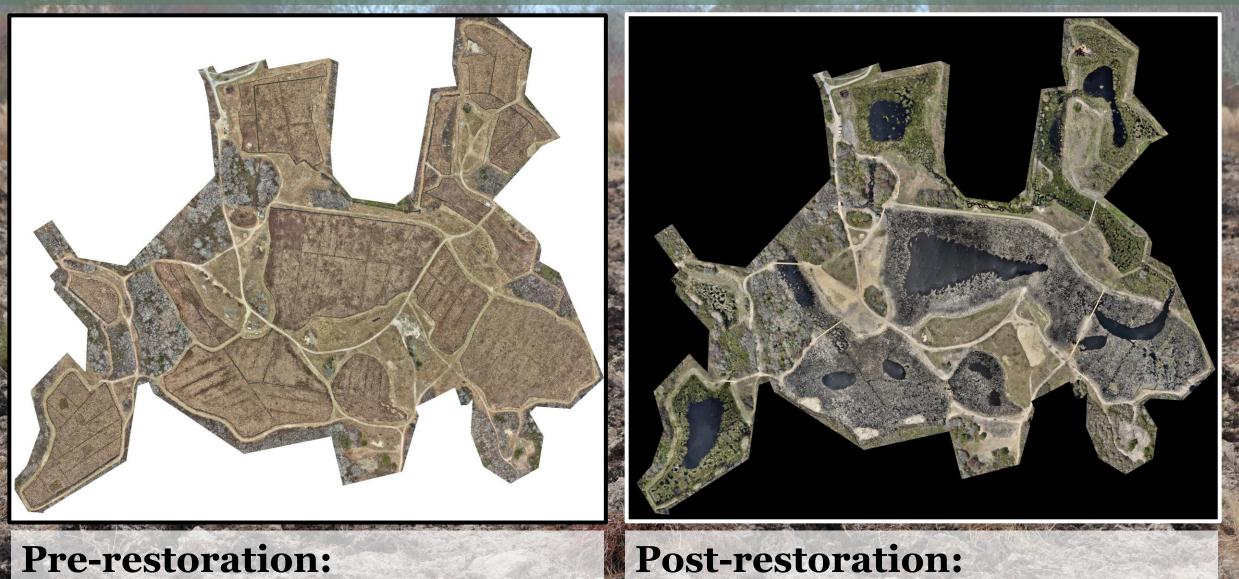
Restoration Results: Before and After

May 2025

January 2024

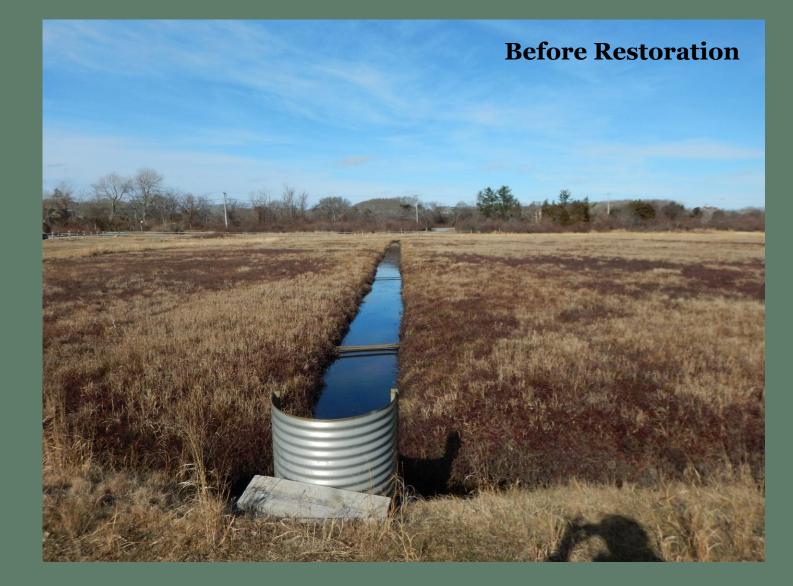
Surface Water Flow Through Site: During Cranberry Farming & Before Wetland Restoration

- Nutrient inputs from ~1,000 acres off-site
- Nutrients inputs from cranberry cultivation (i.e. fertilizers, etc.)
- Simplified landscape: flat topography and deep, efficient drainage ditches
- Water flow concentrated in ditches, increasing flow rates and reducing residence time

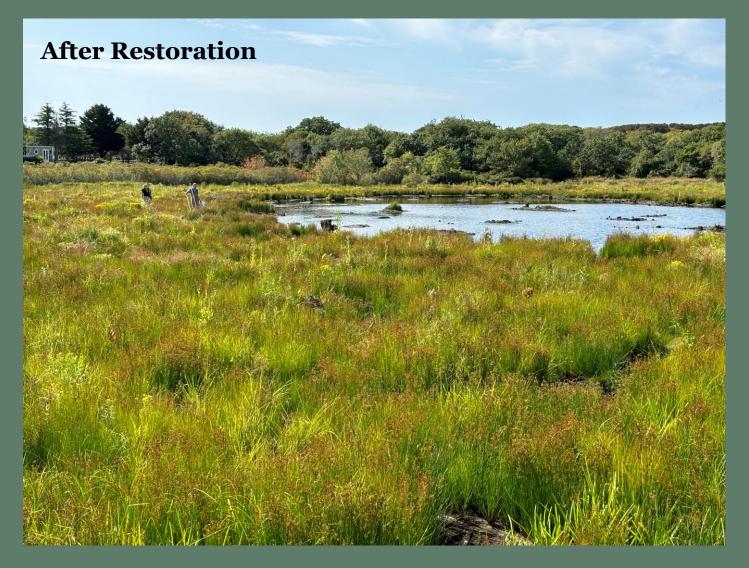
Surface Water Flow Through Site: Post-Wetland Restoration

- Still nutrient inputs from off-site, but none from cranberry cultivation
- Landscape diversity and wetland topography restored
- No flat bog surfaces or drainage ditches- only diffuse flow paths
- Slower water flow and increased retention

THEORY: Natural, slow movement of surface water through restored wetlands → Uptake of excess nutrients by native wetland vegetation → Improved water quality

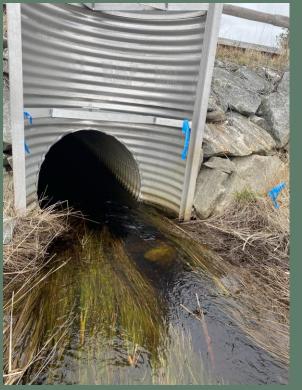
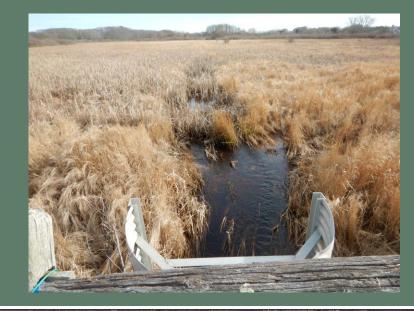
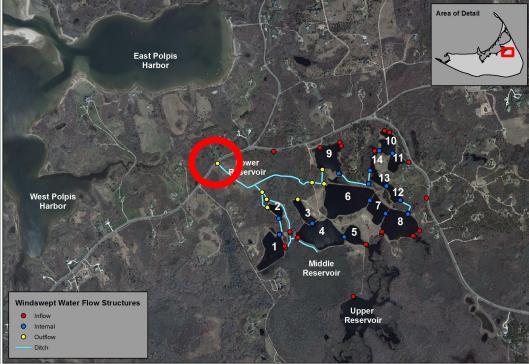
Water Quality Sampling at Windswept Exit Culvert

- NCF is conducting ongoing nutrient sampling (monthly, year-round) beginning in March 2023
- Data analyzed and reported by SMAST Lab: Salinity,Conductivity, uM PO4, uM TP, uM NH4, uM NOx, uM DIN, uM DON, uM TDN, uM POC, uM PON, C/N Ratio, uM TON, uM TN, Chla, Phaeo, Total Pig

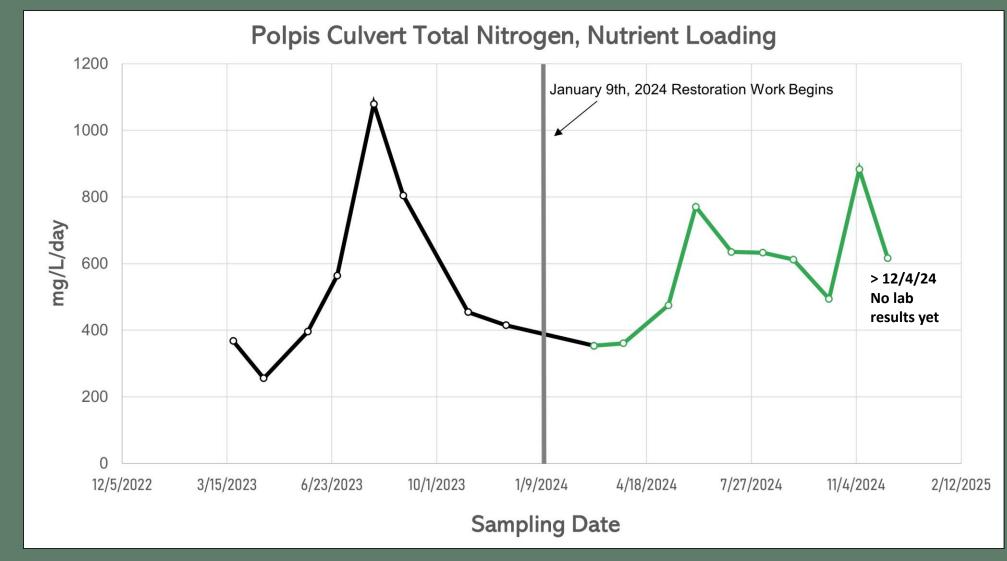
Very Preliminary Nitrogen Loading Results*

*This graph represents nutrient loading for Total Nitrogen during 2023 and 2024. Samples were taken monthly at the Polpis Road culvert exiting the Windswept site. Due to a lack of discharge data, an average discharge value was calculated in May and June of 2025 and is approximately 500 cubic meters/day. This may affect the nutrient loading values for this study site but still provides information into the changing nutrient profiles pre and post restoration.

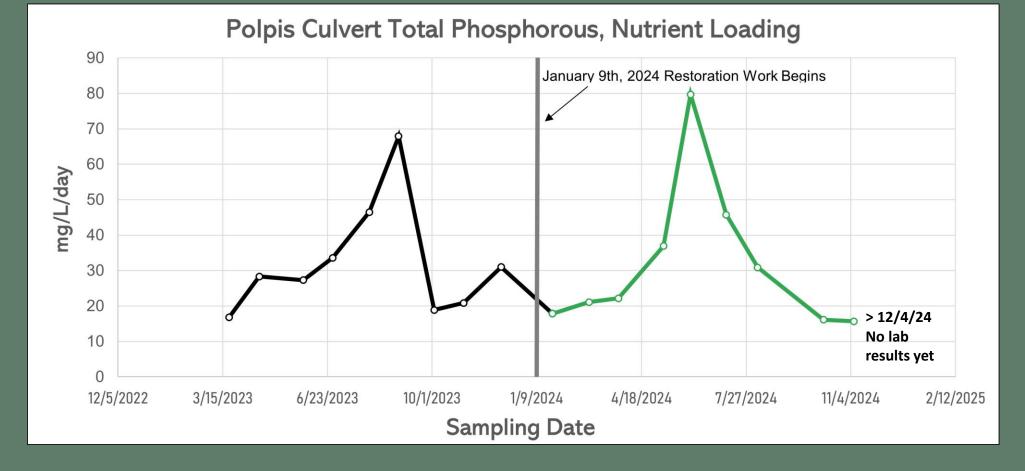
Very Preliminary Phosphorus Loading Results*

*This graph represents nutrient loading for Total Phosphorus during 2023 and 2024. Samples were taken monthly at the Polpis Road culvert exiting the Windswept site. Due to a lack of discharge data, an average discharge value was calculated in May and June of 2025 and is approximately 500 cubic meters/day. This may affect the nutrient loading values for this study site but still provides information into the changing nutrient profiles pre and post restoration.

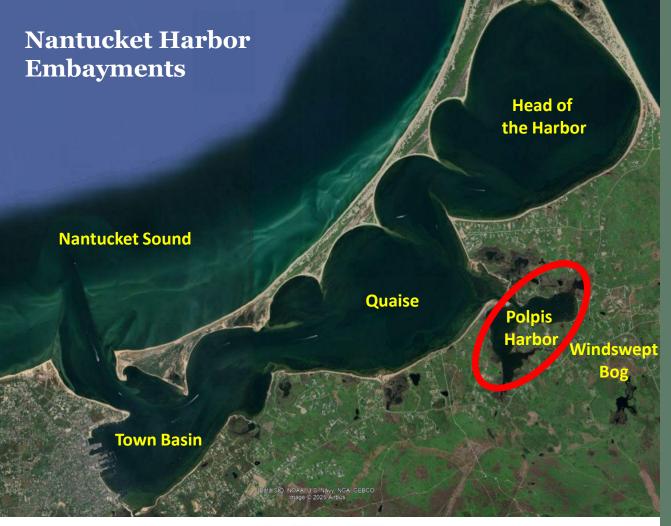
- Polpis Harbor is currently impaired for high levels of nitrogen and bacteria
- Impaired water quality reduces the health and resilience of salt marshes
- One of the main coastal resilience challenges facing Nantucket Island is degradation and loss of estuarine habitats and their buffering capacity
- Improved water quality discharging from Windswept into Polpis Harbor will assist with estuarine resilience and overall harbor health

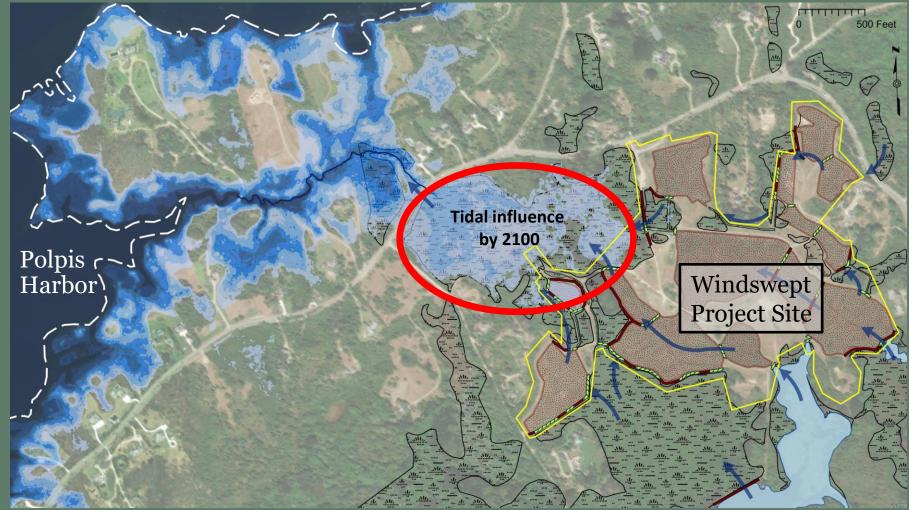
- NOAA Projections show a portion of the Windswept site under tidal influence by 2100
- Expanded acreage of low elevation wetlands adjacent to the coast will buffer flooding and increase resiliency
- Windswept will be a pathway for sea level rise and salt marsh migration
