# Chappy Saltmarsh Restoration Project

MV Coastal Conference – October 6th, 2026

### Building Beach and Salt Marsh Resilience to Protect Island Communities in Massachusetts: Salt Marsh Restoration on Chappaquiddick Island Martha's Vineyard

CHAPPAQUIDDICK ISLAND  
SALT MARSH RESTORATION PROJECT  
EDGARTOWN, MA

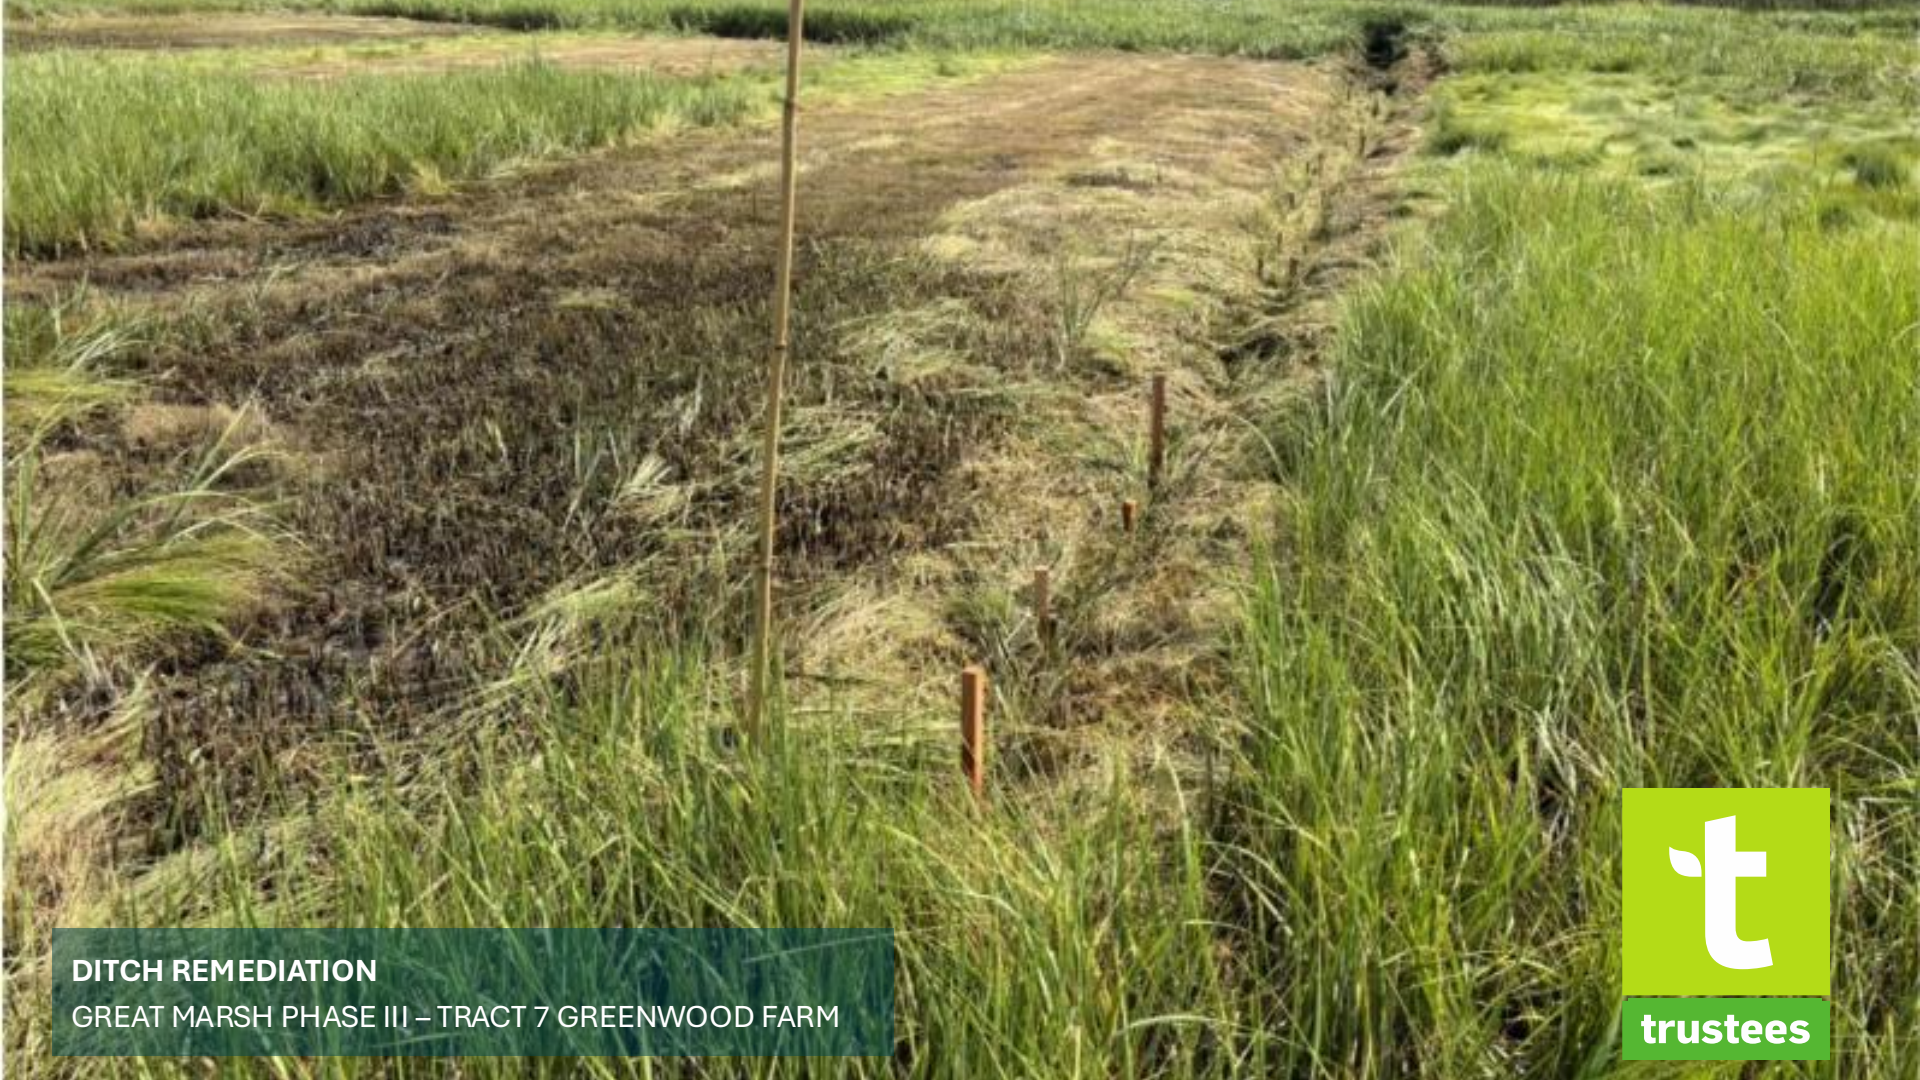
A photograph of a marsh landscape. In the center, a narrow, straight ditch runs from the background towards the foreground. The ditch is bordered by tall, green grasses on both sides. The grasses in the foreground are very dense and tall, reaching up to the top of the frame. The ditch itself appears to be a mix of water and mud, with some green algae or moss growing along its edges. In the background, the marsh continues with more grass and a few small trees or shrubs visible on the horizon. The sky is not visible. The overall scene is a natural, somewhat overgrown marsh area.

**DITCH REMEDIATION**  
GREAT MARSH PHASE III – TRACT 7 GREENWOOD FARM

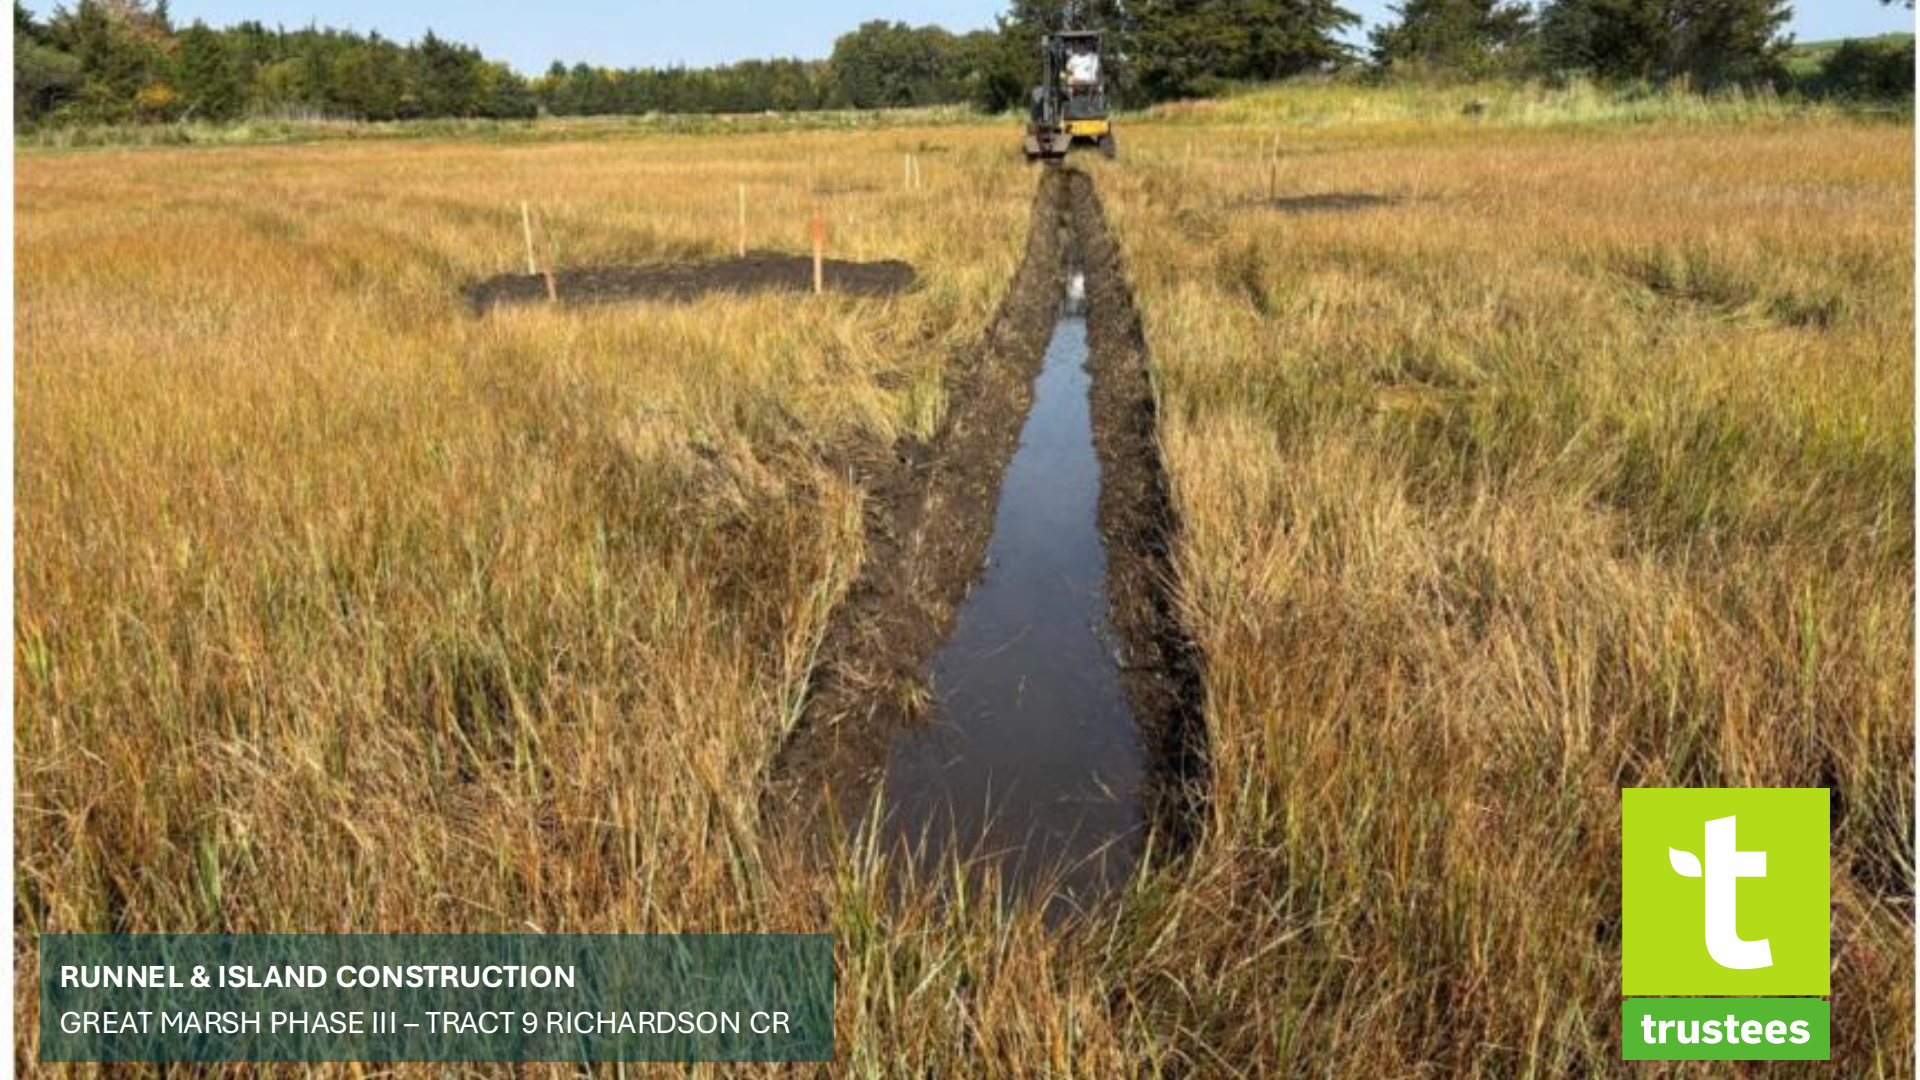
**RUNNEL & ISLAND CONSTRUCTION**  
GREAT MARSH PHASE III – TRACT 9 RICHARDSON CR

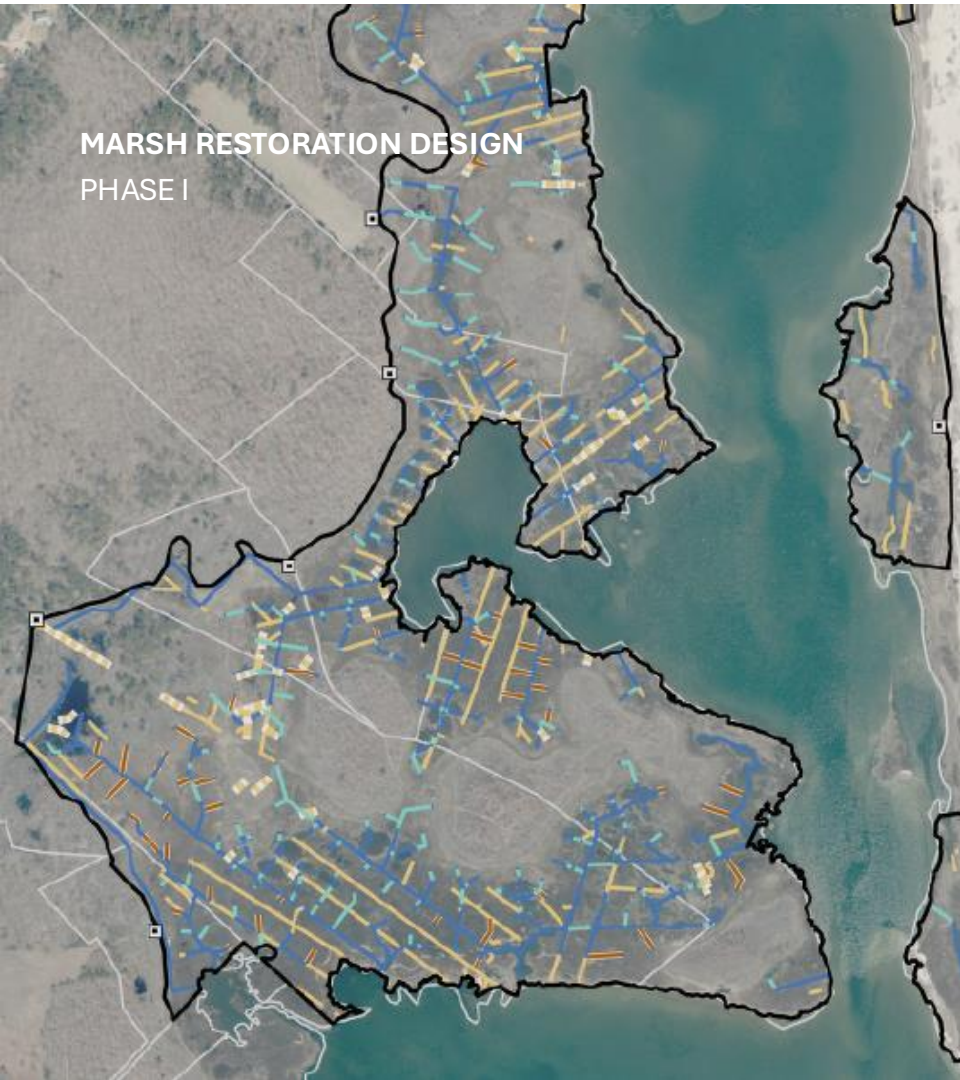
**MARSH RESTORATION DESIGN**  
**PHASE I**

DITCH REMEDIATION - LINEAR TREATMENT
-

DITCH REMEDIATION - POINT TREATMENT
-

TIDAL CHANNEL RESTORATION - EARLY SUCCESSIONAL
-

TIDAL CHANNEL RESTORATION - LATE SUCCESSIONAL
-
