Sconset Geotextile Tube Update

'Sconset Bluff, Nantucket

Epsilon
ASSOCIATES INC.

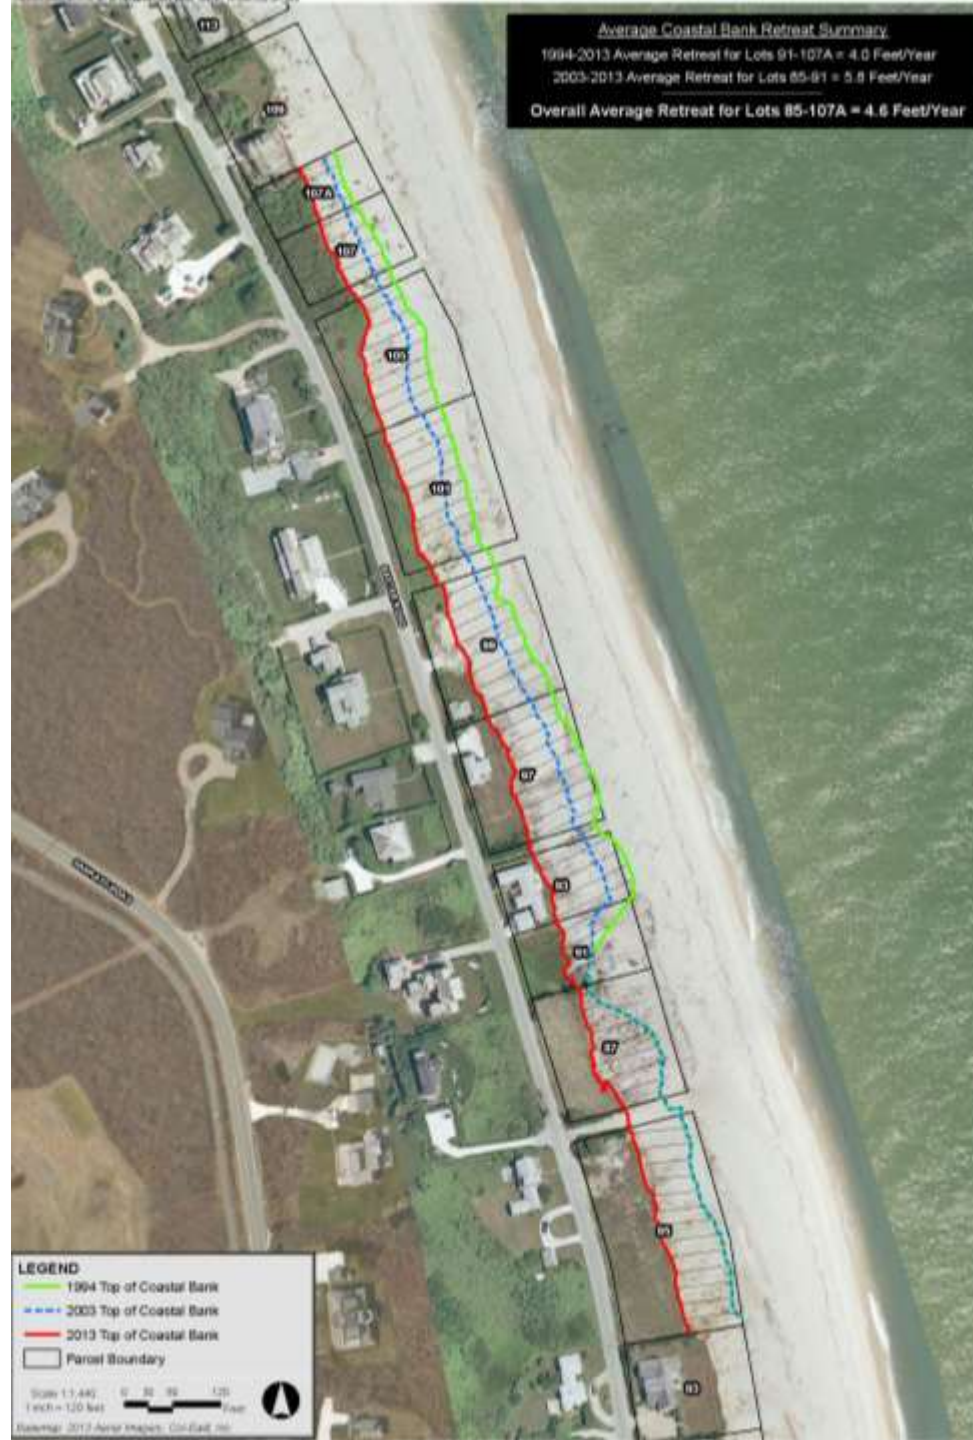
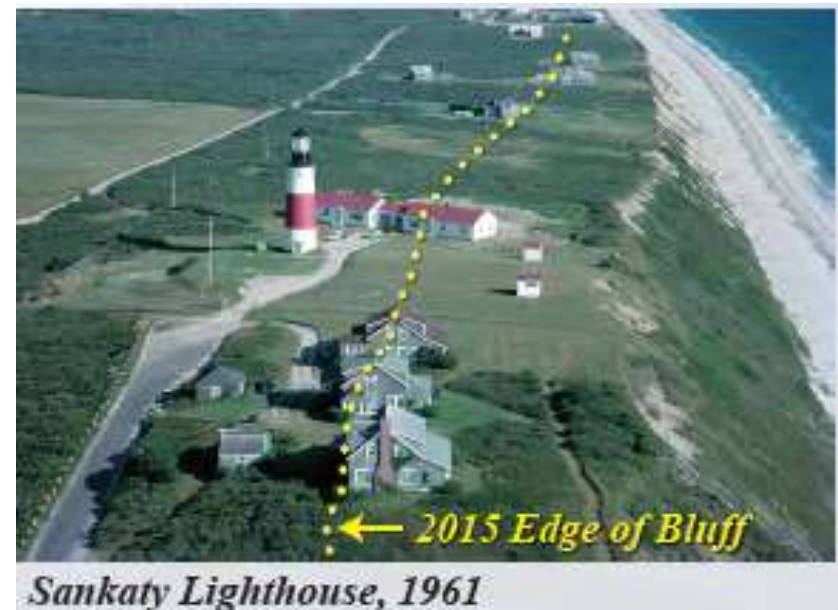
Coastal Bank Retreat

- Long-Term Average: 4.6 feet/year
- Potential Single Season Loss: 20-30+ feet/year
- Winter 2012-2013 resulted in catastrophic erosion

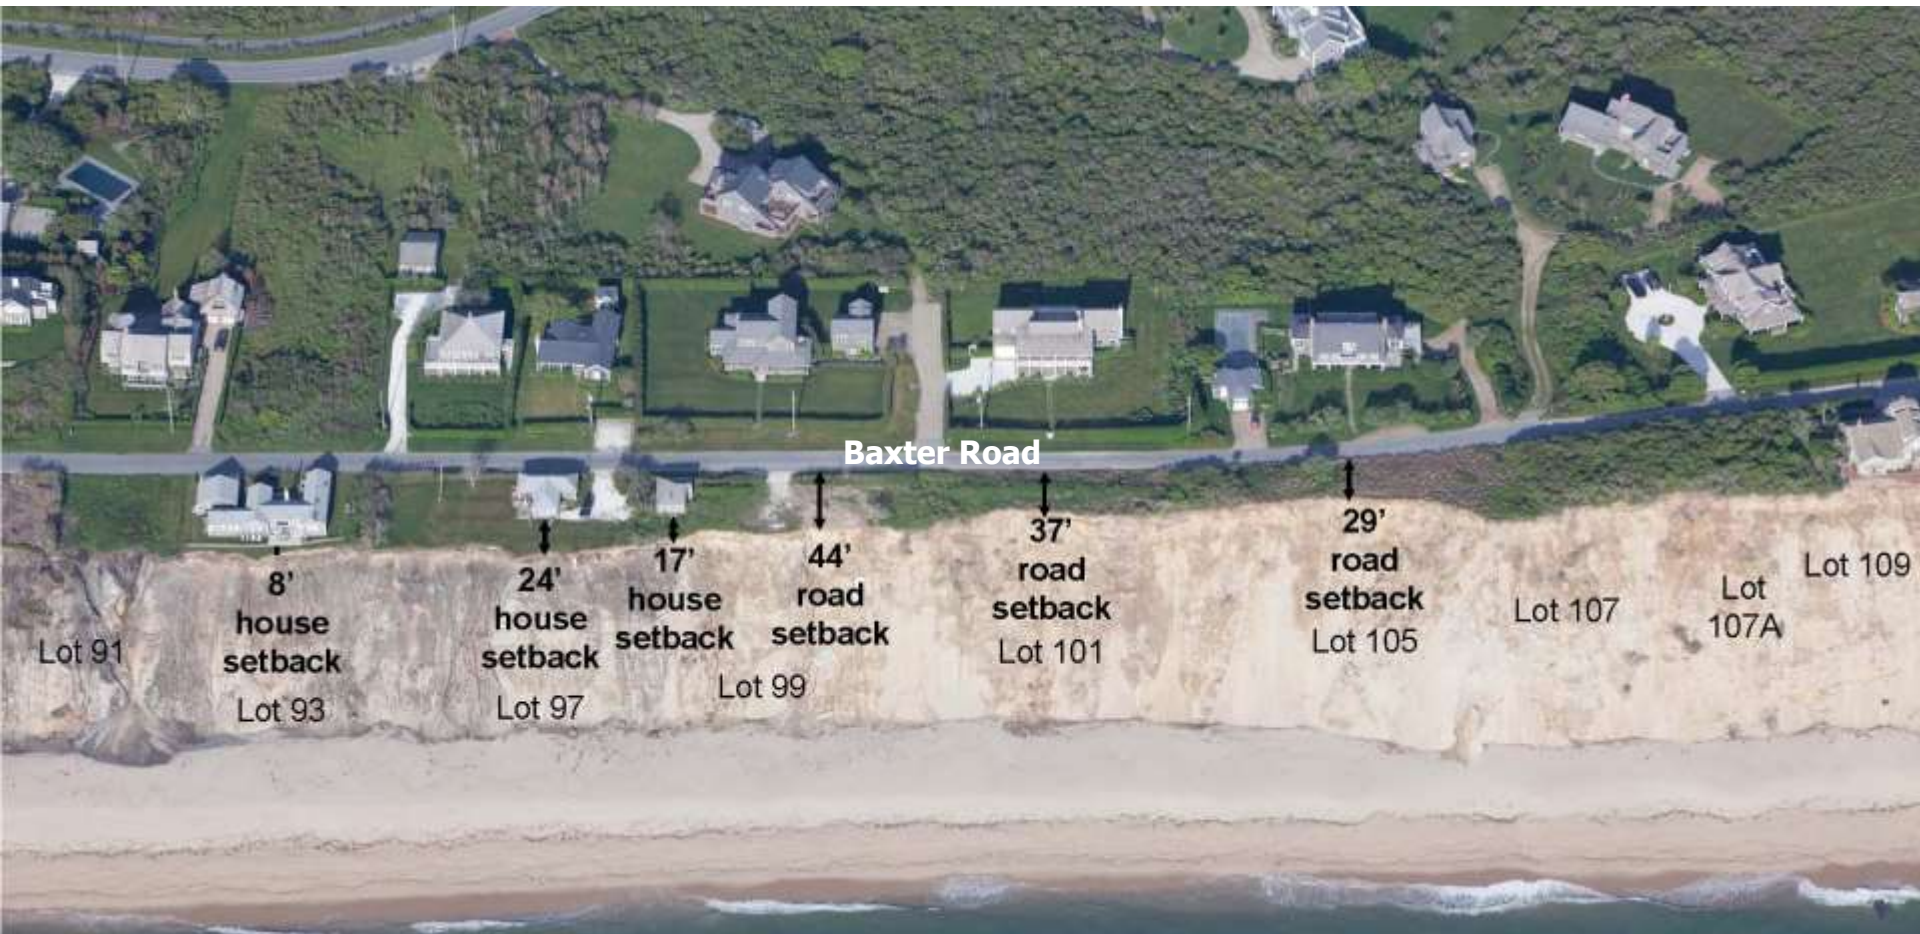
Existing Conditions (June 2013)

109-91 Baxter Road

- **Baxter Road, homes, and associated utilities (water/sewer) in imminent danger**
- **Geotechnical engineer advised closure of road when within 25 feet of bluff edge**
- **Town of Nantucket has legal obligation to provide access to homes**
- **Town of Nantucket and SBPF entered partnership to sponsor erosion control project**

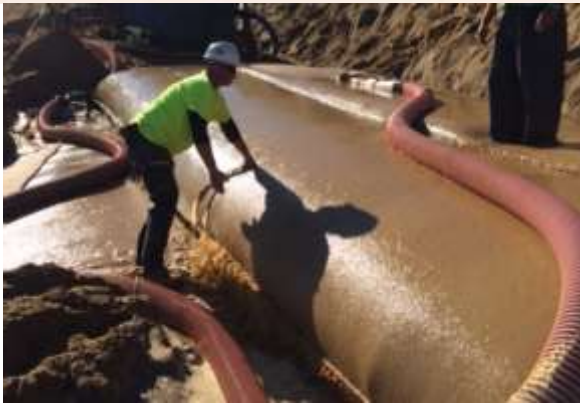
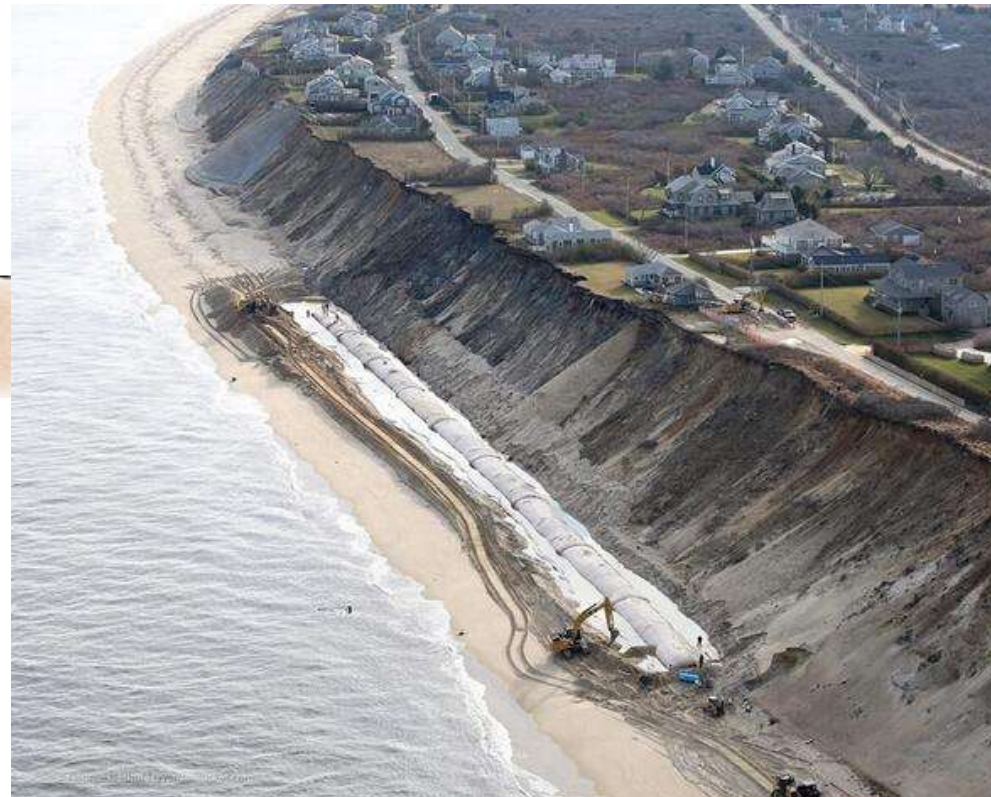
Geotextile Tube Project

- Preferred due to ability to withstand storm waves, sloped design (decreases wave reflection), ease of installation and, if necessary, removal.
- Fabricated from high strength, woven polypropylene sewn into a tube shape.
- Three-four rows of 45' circumference geotextile tubes, each about 19' wide, 7' tall, and 100-200' long.
- Two phases of construction: three tiers installed in December 2013/January 2014; fourth tier and returns installed October through December 2015. Total length 947 feet.

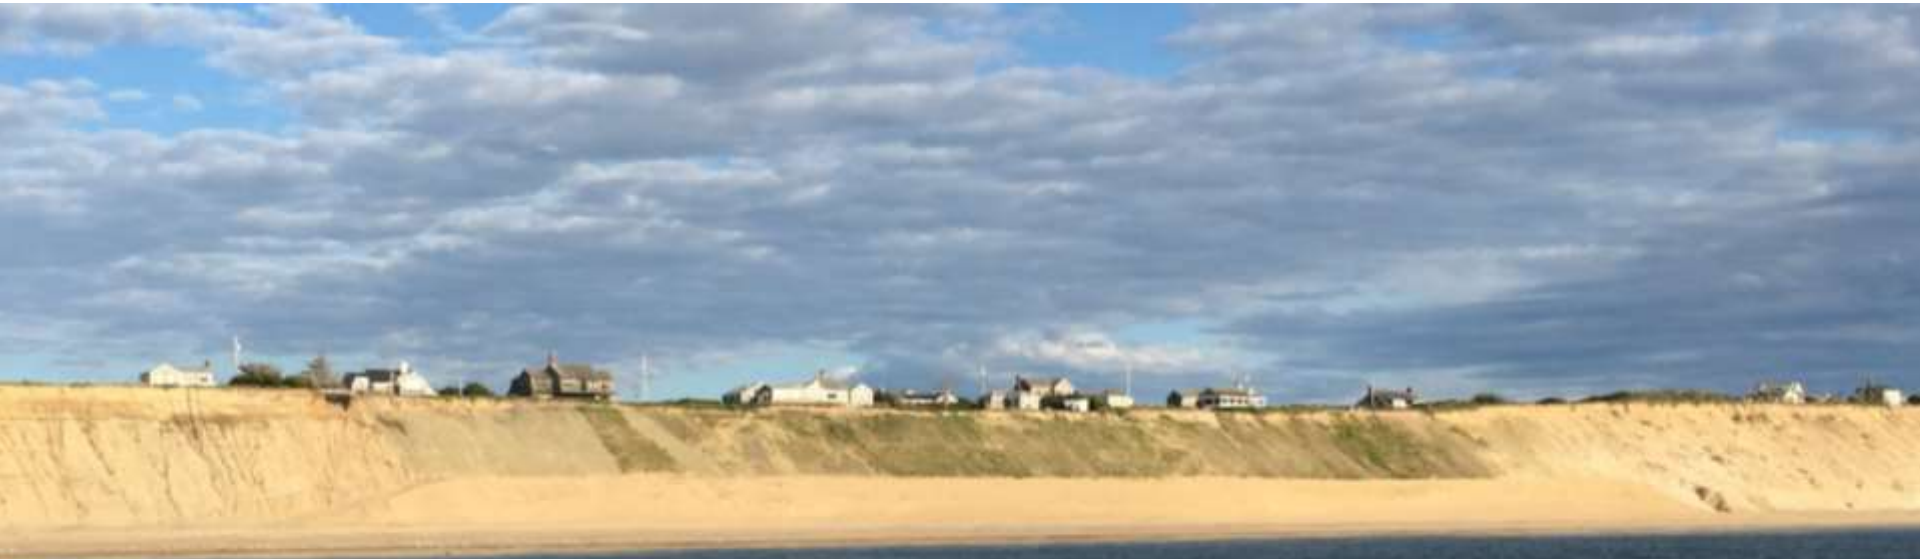
Sand Mitigation

- **Protection of bluff prevents it from serving as a sediment source and requires mitigation**
- **Massachusetts typically requires annual mitigation equivalent to average annual contribution**
- **Project provides 22 cy/lf/yr, which is equal to 1.5 times average annual bank contribution**
- **Total volume ~20,000 cy sand/yr**

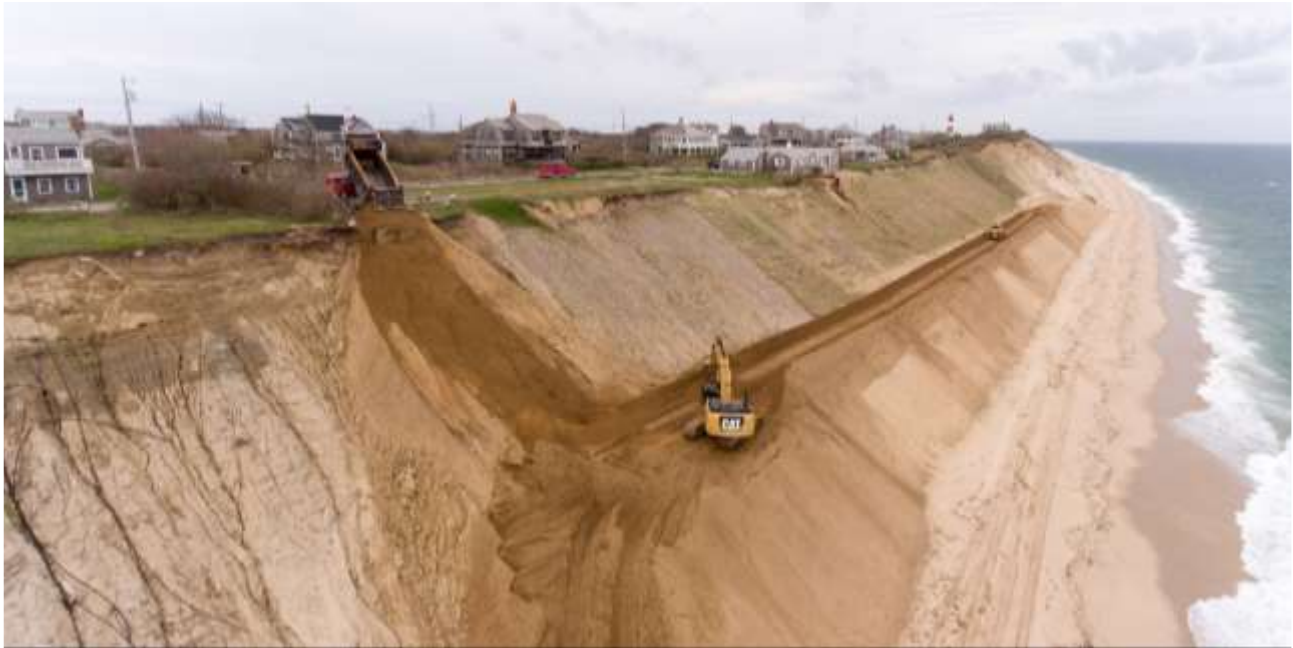
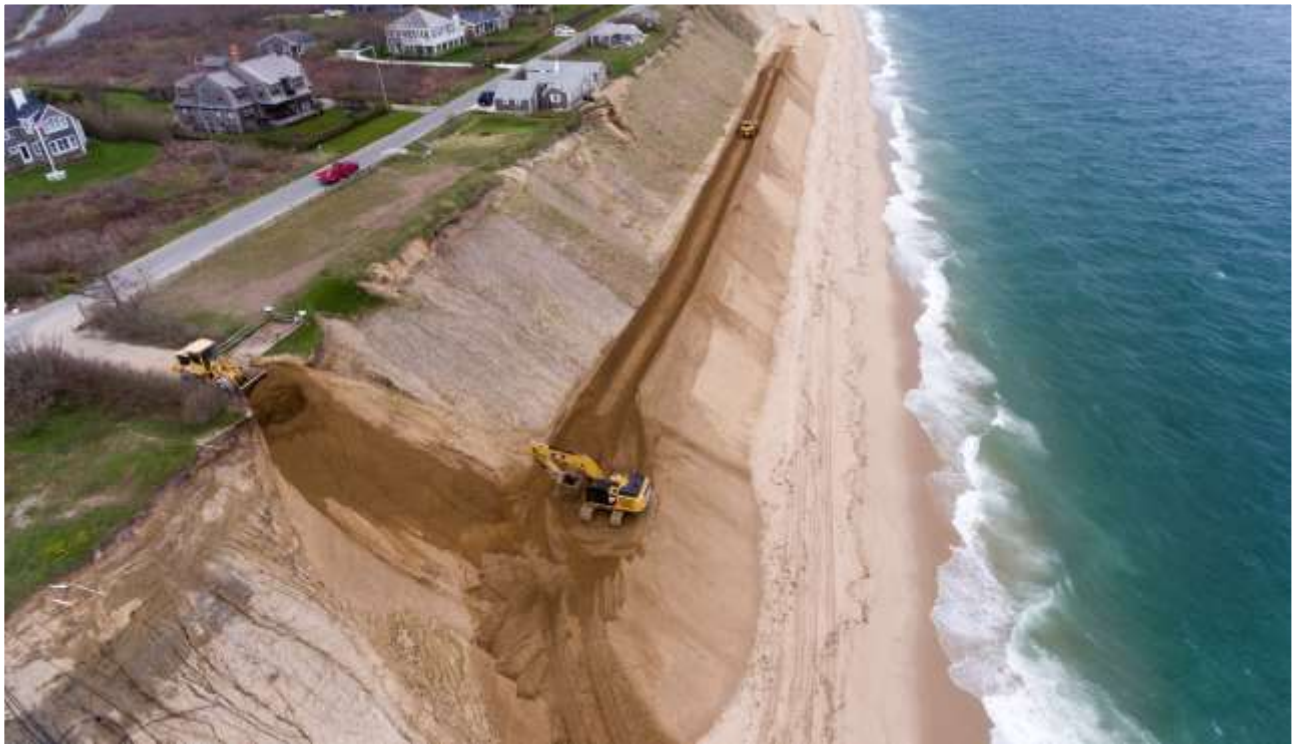
Sand Delivery

- Sand brought to the site by dump truck from on-island pits
- Sand delivery occurs during off-season months only

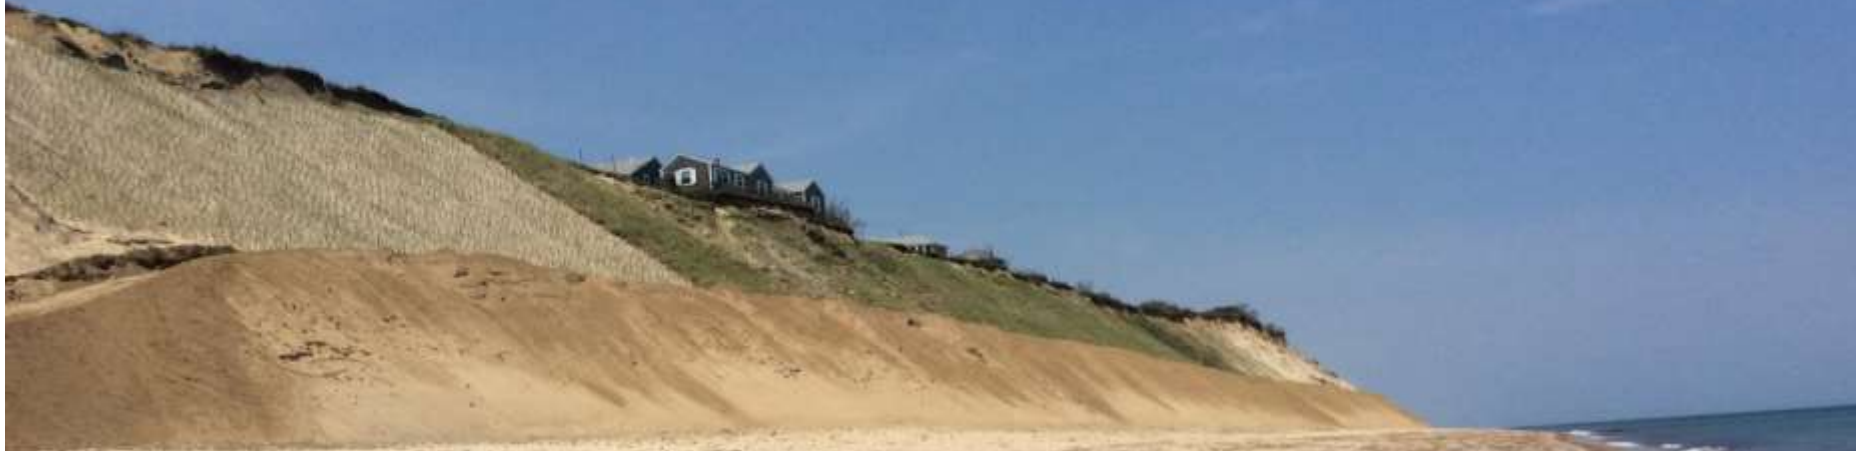
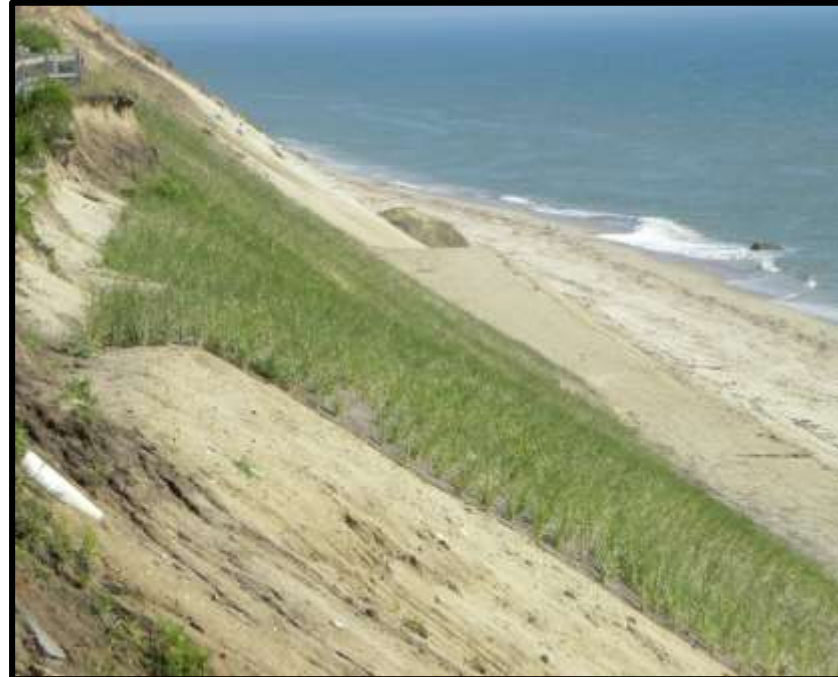
- Once the base of the bluff was protected by the geotextile tubes, the face of the bluff could also be stabilized by adding vegetation.
- Vegetation helps to prevent erosion from wind, rain, and stormwater runoff.
- American Beachgrass planted in spring 2015; additional planting occurred in spring 2016 above the new returns.

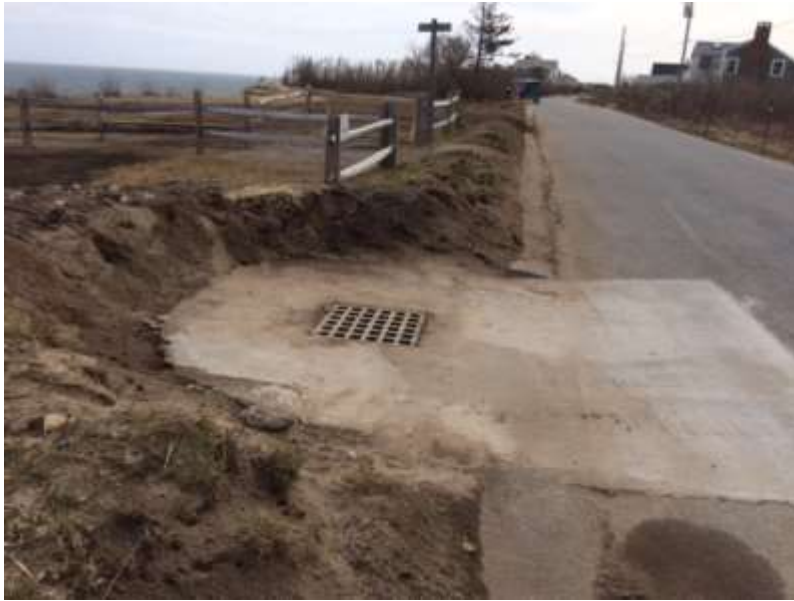
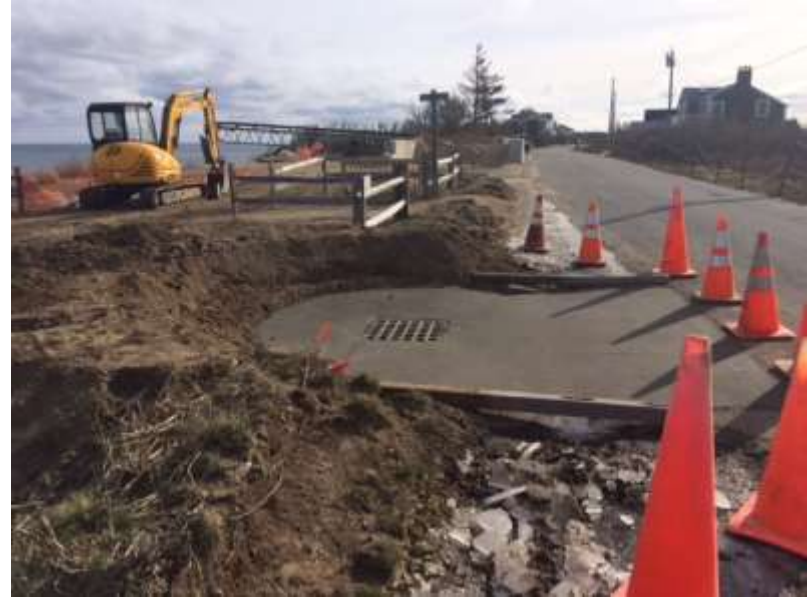
Stormwater Drainage System

- Top and face of bluff can erode from wind, rain, and stormwater runoff.
- In January and February 2016, a drainage system was installed on Baxter Road. This drainage system serves to capture stormwater runoff and redirect it, so that it no longer causes erosion from the top of the bluff.
- Berm installed along roadway where needed to redirect stormwater runoff away from the face of the bluff.

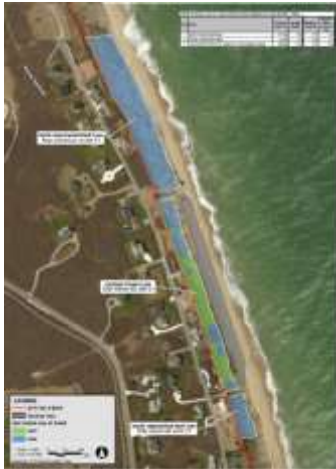
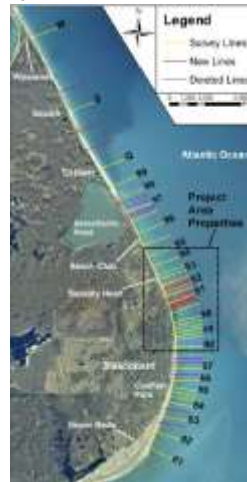
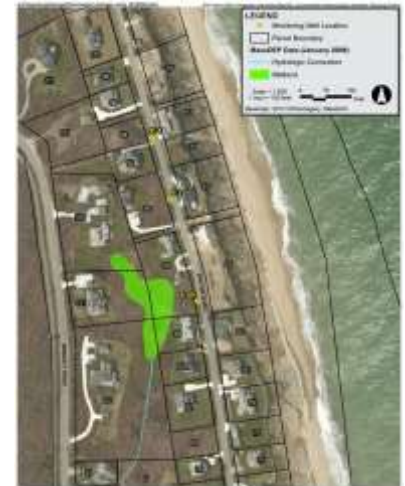
- Annual Bluff Monitoring
- Quarterly Shoreline Monitoring
- Wetland Well Monitoring

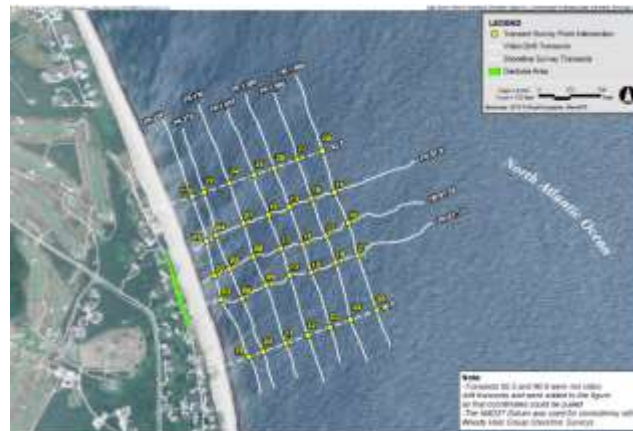
- Semi-annual Underwater Video Monitoring

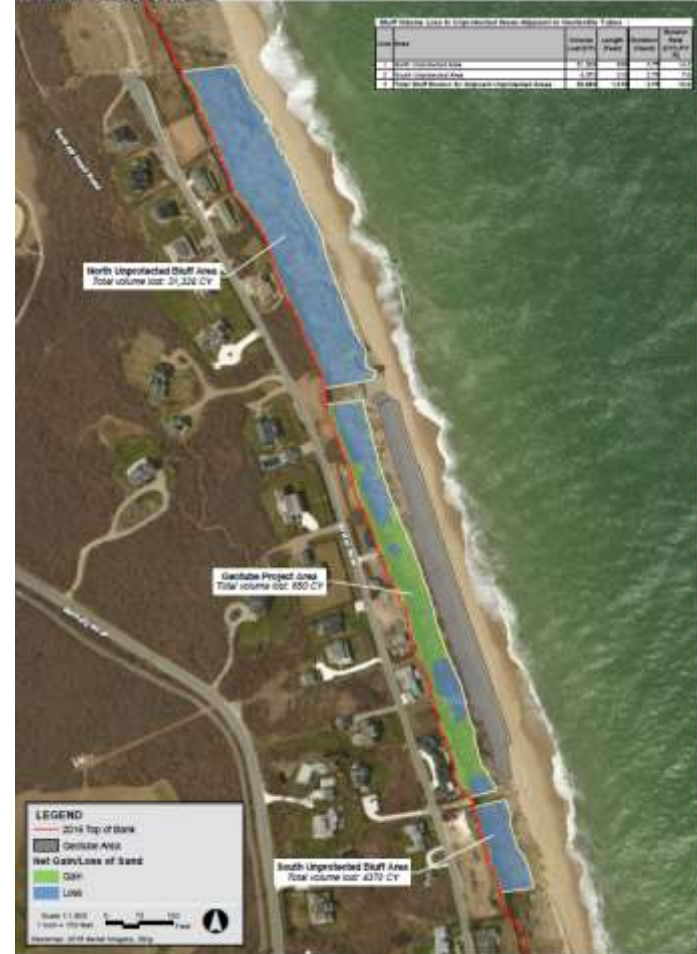
Annual Aerial Survey of Bluff

- The first annual aerial survey was performed of the Project area on April 2, 2016. Second annual survey just completed late May 2017.
- The results of the 2016 aerial survey were compared to the 2013 aerial survey for those unprotected areas immediately adjacent to the geotextile tube project.
- Unprotected bluff contribution volume was 12.9 cy/lf/yr, which is 59% of mitigation volume.

Bluff Volume Loss in Unprotected Areas Adjacent to Geotextile Tubes

Line	Area	Volume Lost (CY)	Length (Feet)	Duration (Years)	Erosion Rate (CY/LF/YR)
1	North Unprotected Area	31,329	800	2.75	14.2
2	South Unprotected Area	4,370	210	2.75	7.6
3	Total Bluff Erosion for Adjacent Unprotected Areas	35,699	1,010	2.75	12.9

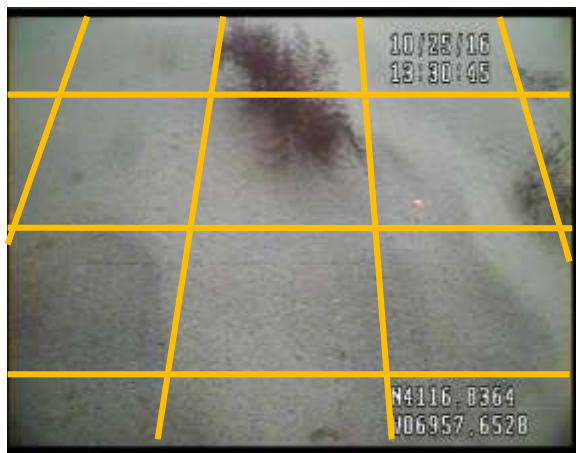
5. Sand Waves or Ripples 95%, Pebbles 5%). TR-400

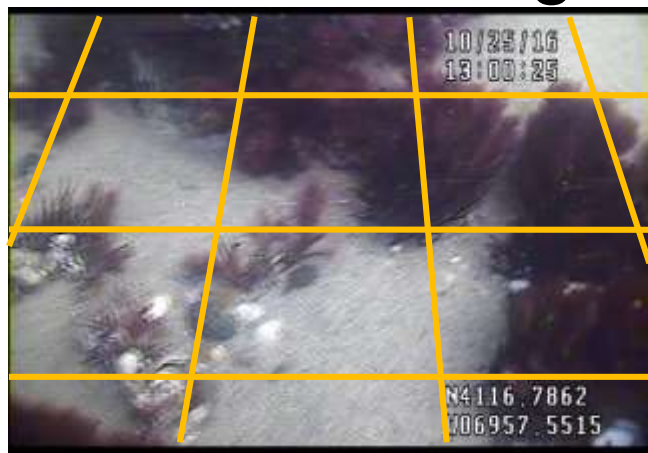
9. (Flat Sand 30%, Pebble 5%, Cobble 30%, Boulder 35%). TR-710.

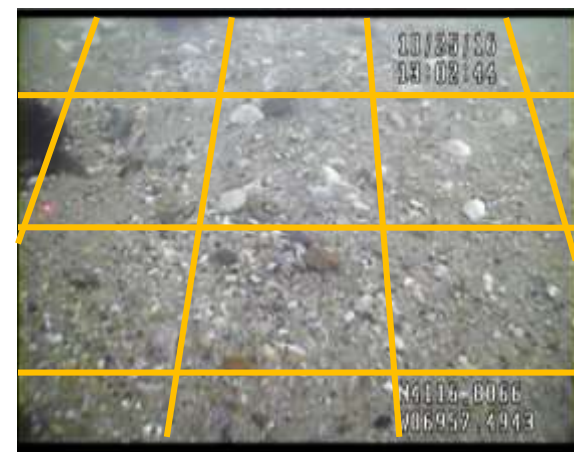
12. (Pebble 100%). TR-1020.

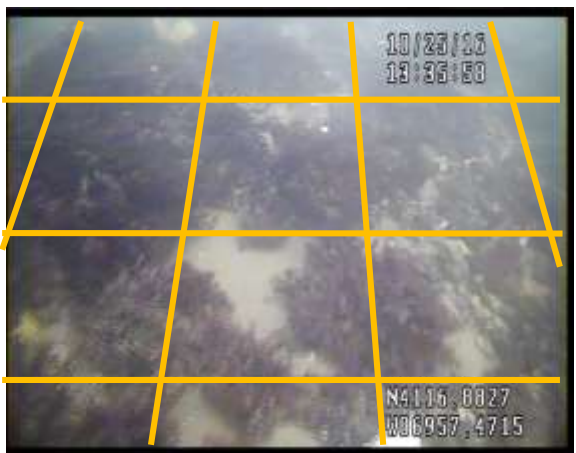
14. (Flat Sand 15%, Pebble 50%, Cobble 35%). TR-1265.

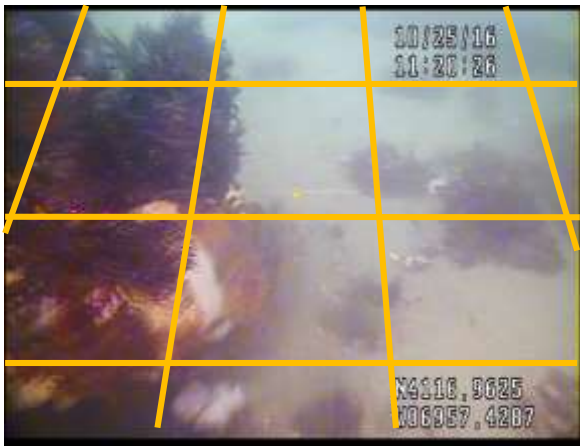
16. (Flat Sand 45%, Pebble 15%, Cobble 10%, Boulder 30%). TR-1500.

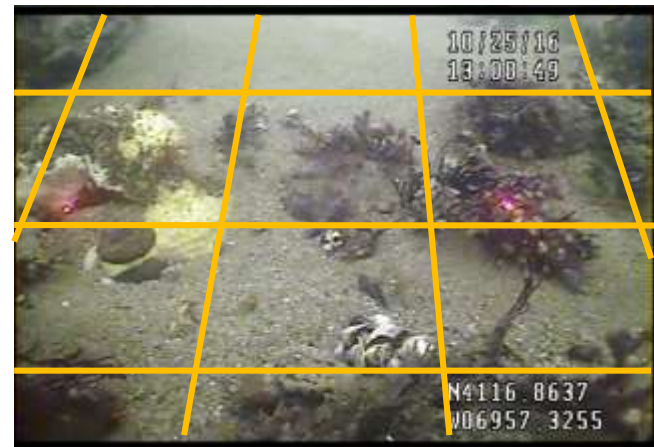
21. (Flat Sand 30%, Pebble 50%, Cobble 20%). TR-1925.

Biota: June and October identified invertebrate species, fish species, and marine plant and algal species, with some seasonal variability (spider crabs bury into sediments; black sea bass, scup, and skates move offshore). Branching brown and red algae, bread crumb sponge, and rock crab were dominant biota. No indication of adverse effect on marine biota.
